Your survey and valuation report

12 Harlestone Close
Luton
LU34DW

13th March 2024

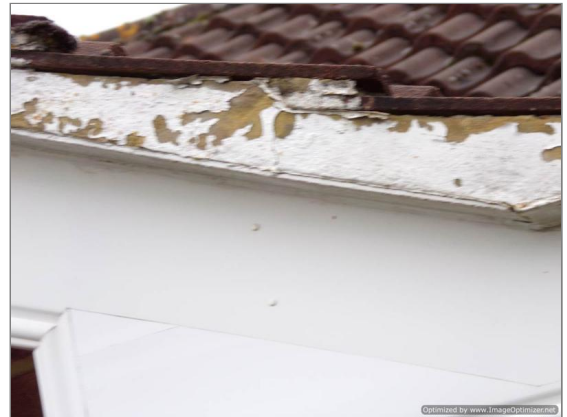
The main roof covering is a pitched design, covered with tiles that appear in reasonable condition for their type and age. However, mortar pointing on some of the ridge tiles has eroded, and cracks/defects were noted on the roof verge. The cracked mortar should be re-pointed with weather resistant mortar mix for durability. We recommend repairs to prevent water ingress, timber decay and dampness. The roof structure is generally performing its function, though some repairs will be required.

Photo - 3 Defects noted on roof verge

Condition rating 2: Clear moss from roof surfaces/general repairs and maintenance required.

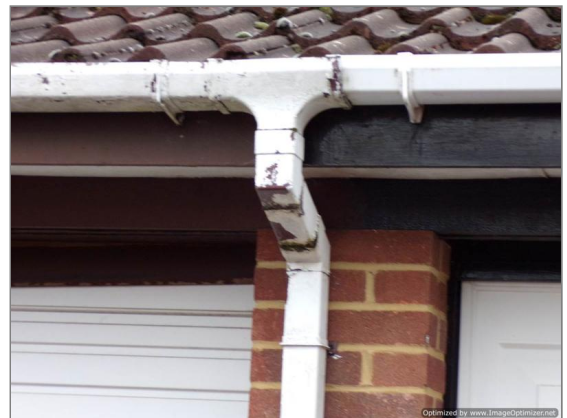
Rainwater goods comprise mainly PVC sections, hopper heads, downpipes, gully, and gutters. The downpipes appear in reasonable condition, though we observed defects to the rainwater goods generally, during our inspection. We cannot confirm whether the rainwater goods would be effective during periods of heavy or prolonged rainfall.

Photo - 14 Defective rainwater goods

Condition rating 2. Repair leaking PVC sections/general repairs and maintenance are required.

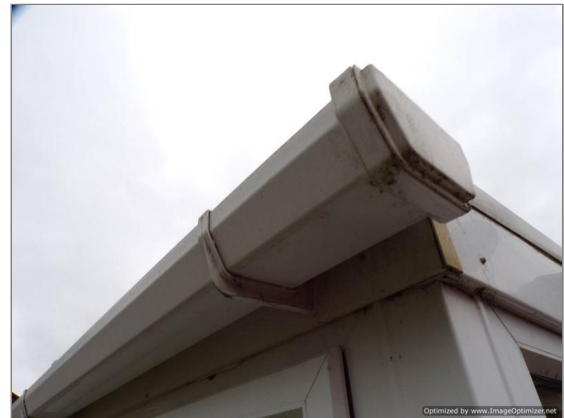
The presence of any significant staining to fascia boards or superstructure, PVC section joints would appear to suggest there are defects/leakages at the present time.

Photo - 16 Staining on the rain water goods.

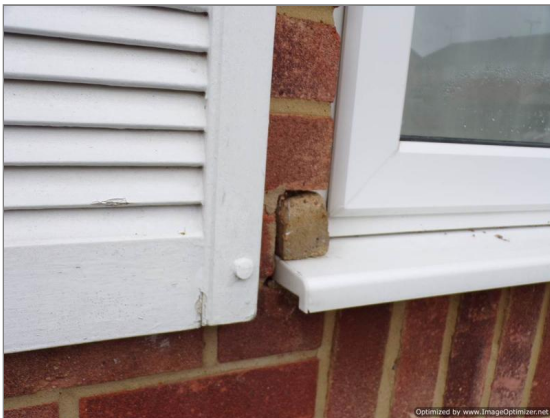
Some evidence of distortions, cracking to mortar pointing, defects and weathering were noted on wall surfaces and around openings. These areas should be repaired to prevent water ingress. Mortar pointing has slightly perished in some areas. Localised repointing and making good is required for areas of soft mortar between the bricks to prevent further deterioration and minimise the risk of damp penetration.

Photo - 21 Defects noted

Condition rating 3: Further specialist damp investigations/general repairs and maintenance required.

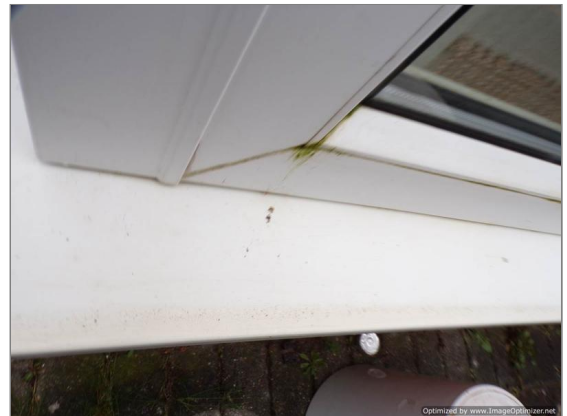
We noted defects/staining and recommended repairs.

Photo - 32 Defects noted

Condition rating 2: General repairs and maintenance required.

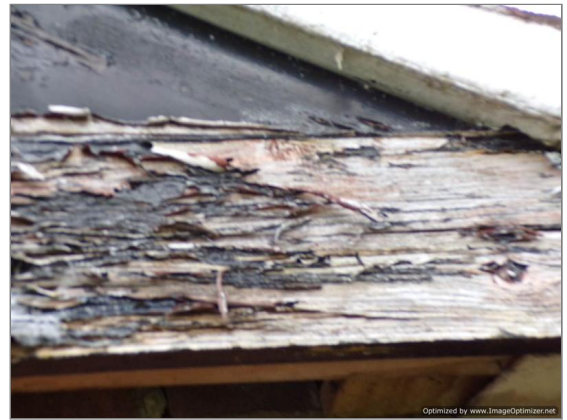
The decorative finishes to the fascia, soffit boards/external joinery are weathered with evidence of timber defects noted. The external joinery have severely deteriorated and we you are advised to plan or budget for its replacement in the near future.

Photo - 38 Defects noted

Condition rating 2 Repair external joinery/general repairs and maintenance required.

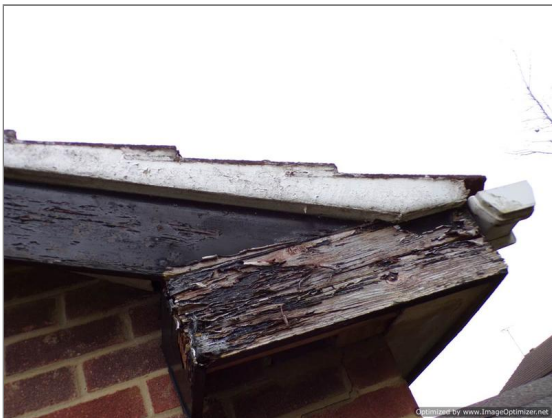
Photo - 39 Timber defect/decay noted

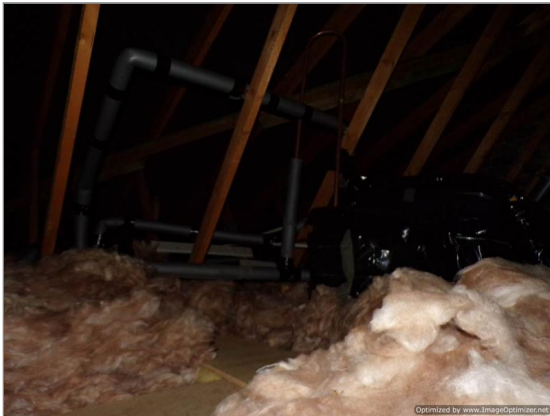
Photo - 44 Water tank noted

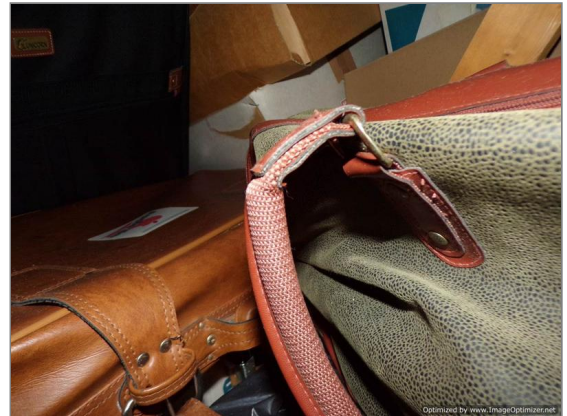
Photo - 45 Several storage items which restricted our inspection

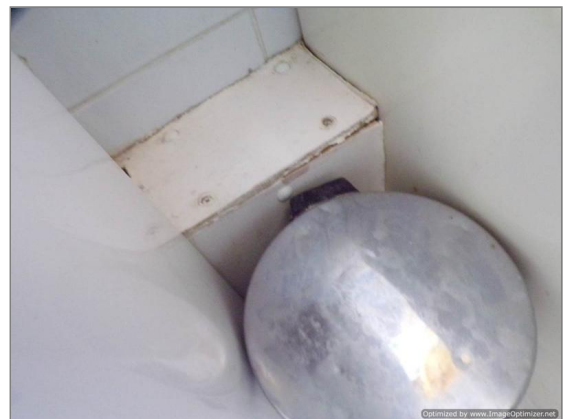
Photo - 92 Defects noted

Condition rating 3: Further leak investigations/general repairs and maintenance are now required.

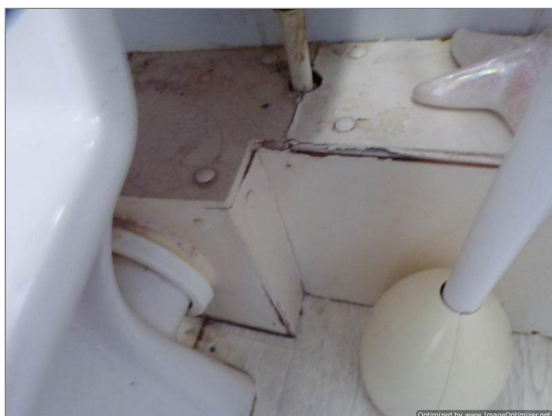
Photo - 93 Defects noted boxing panel

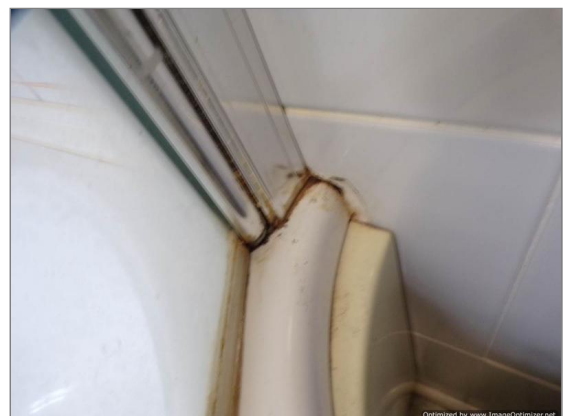
Photo - 94 Leak stains noted on shower screen.
