Your survey report

74 Kenlor Road
London
SW17 0DF

2nd September 2024

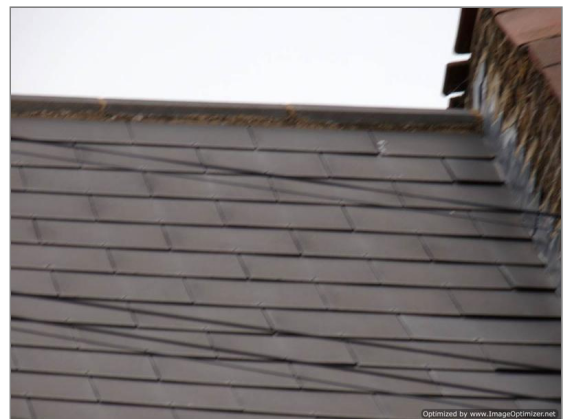
Photo - 8 Possible slipped/defective slates noted.

Condition rating 3: Further roof/leak investigations/general repairs and maintenance are required.

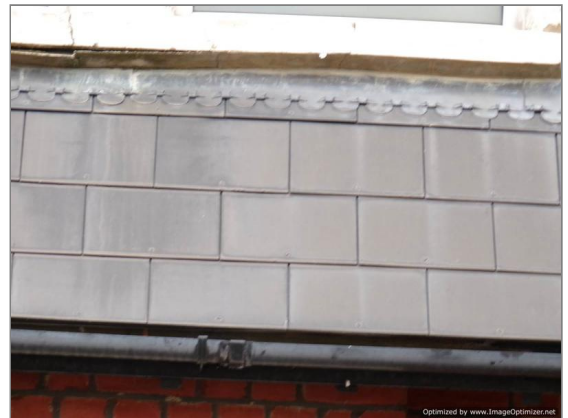
Photo - 12 Defects noted

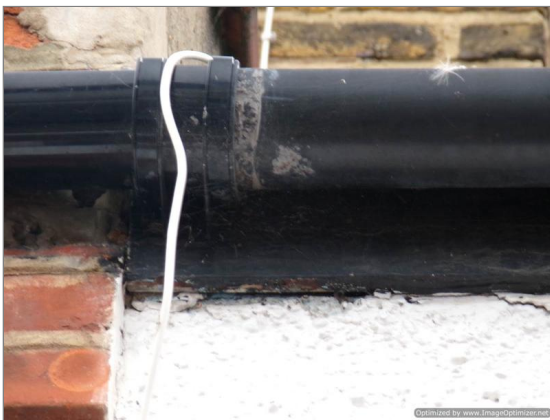
Photo - 19 Staining on the rain water goods.

Condition rating 2. Repair leaking PVC/cast-iron sections/rainwater goods/general repairs and maintenance required.

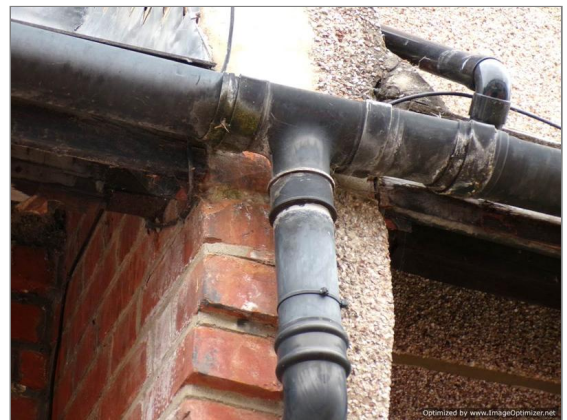
Photo - 20 Defective rainwater goods

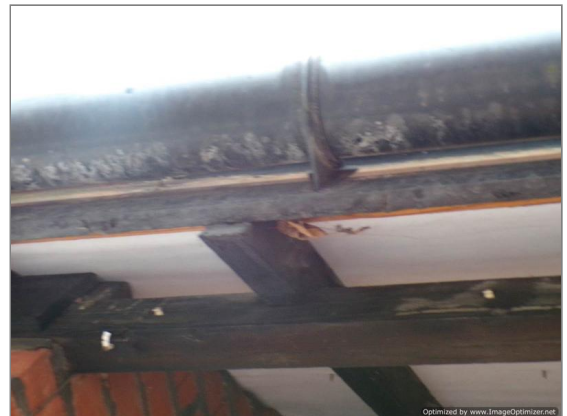
Photo - 22 Defects noted

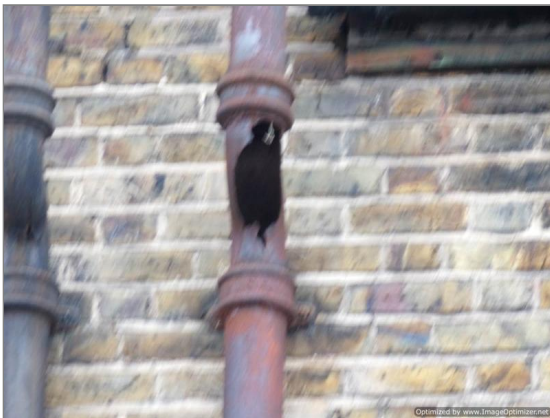
Photo - 25 Rusty and defective soil and vent pipe

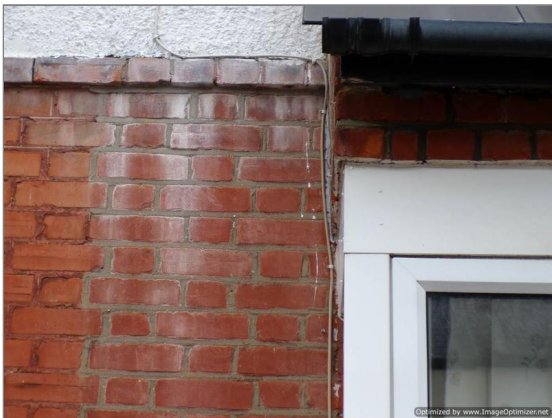
Photo - 30 Possible leak stains noted

Condition rating 3: Further specialist damp,leak, structural engineers investigations/general repairs and maintenance are now required.

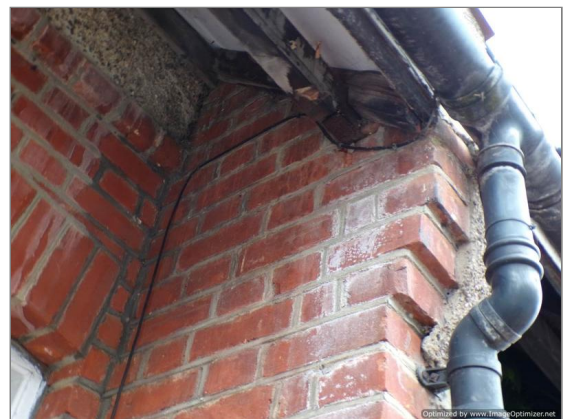
Photo - 33 Possible leak stains/defects noted

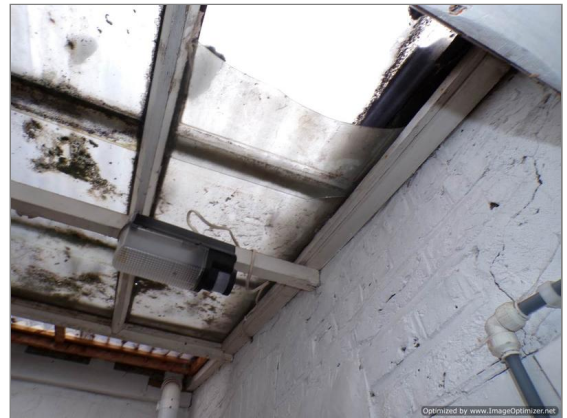
Photo - 41 Evidence of a possible structural movement/defect

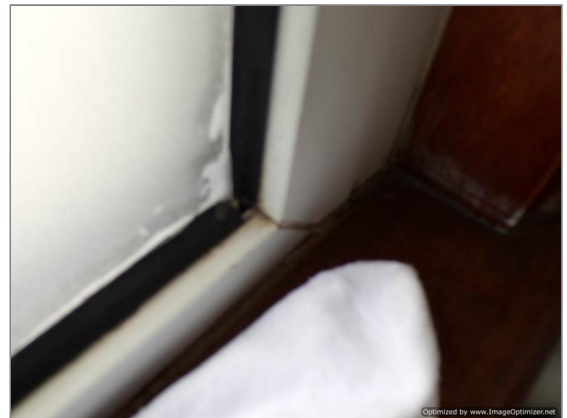
Photo - 53 Leak stains noted

Condition rating 3: Further leak investigations/general repairs and maintenance are required.

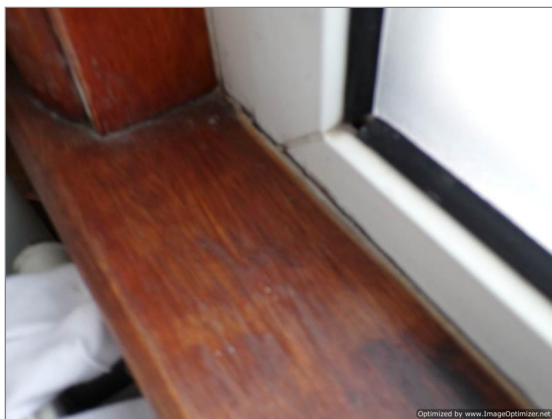
Photo - 54 Cracking/defective sealants noted

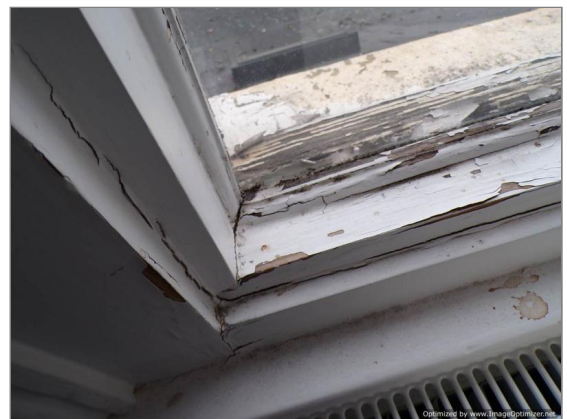
Photo - 55 Cracking/timber decay/defects on windows noted

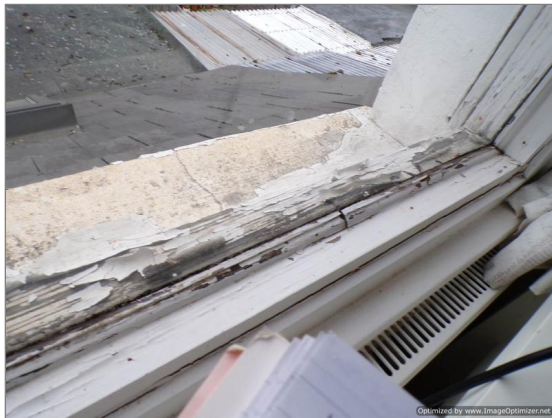
Photo - 56 Defects noted

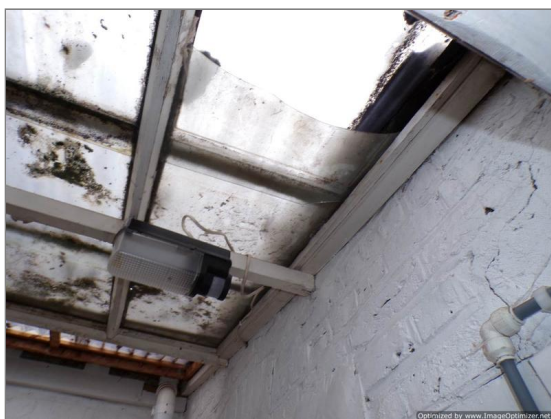
We noted evidence of significant leak staining, timber decay/defects to the underside of the conservatory roof, indicating that the roof is defective, with patches/repairs noted on the surfaces. Further leak roof and leak investigations and repairs are required prior to commitment to purchase.

Photo - 68 Defects noted

Condition rating 3: Replace conservatory/further leak/damp investigations/general repairs and maintenance are required.

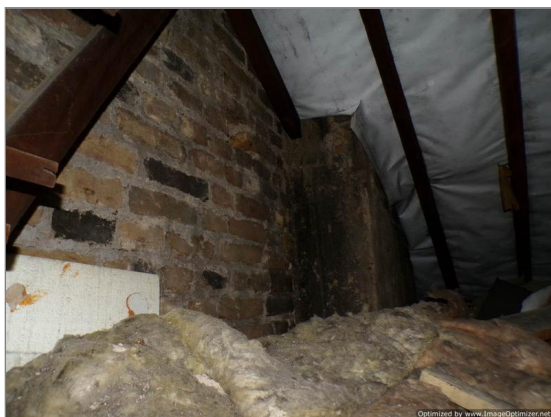
Photo - 73 Leak stains noted on chimney breast

Condition rating 3: Further leak investigations/general repairs and maintenance are required.

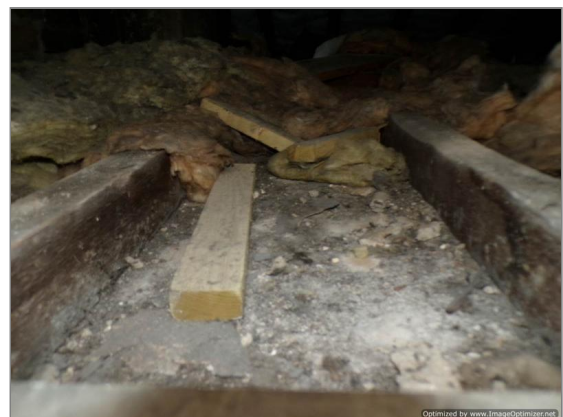
Photo - 74 Inadequate insulation noted in this area

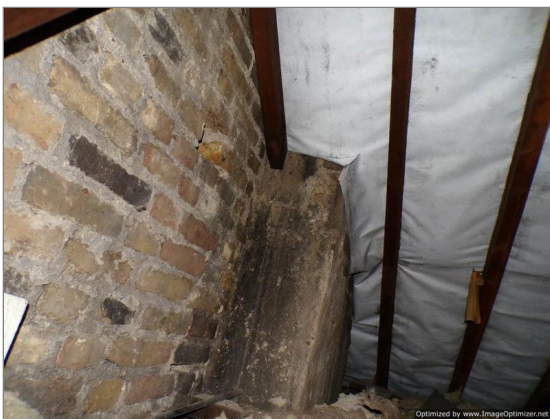
Photo - 79 Leak stains noted

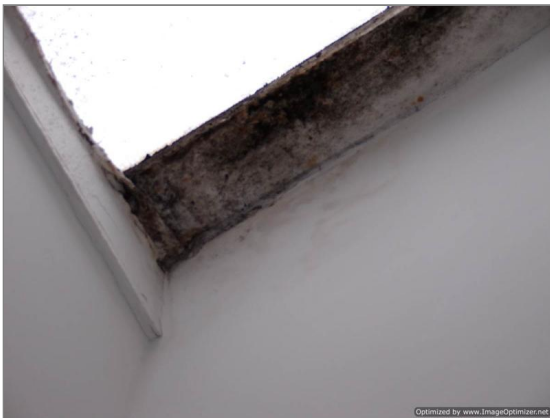
Photo - 85 Leak stains/defects noted

Condition rating 3: Further leak investigations/general repairs and maintenance are required.

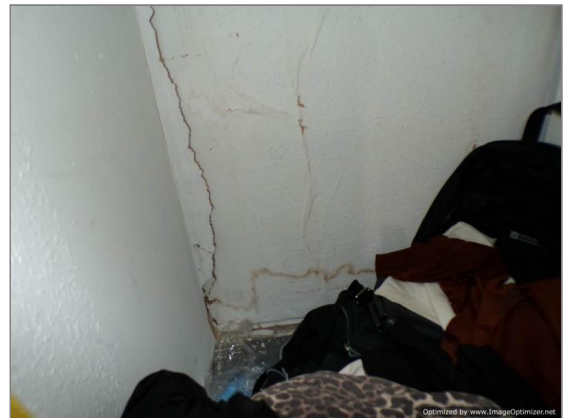
Photo - 116 Evidence of a possible structural movement/
defect/leak stains noted

Condition rating 3: Further investigations/general repairs and maintenance are now required.

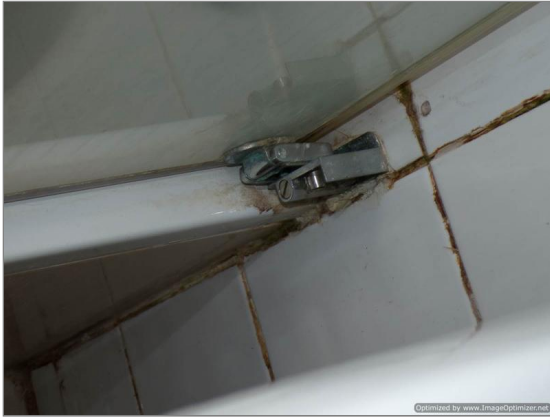
Photo - 165 Leak stains/defects noted

Condition rating 3: Further leak investigation/general repairs and maintenance required.

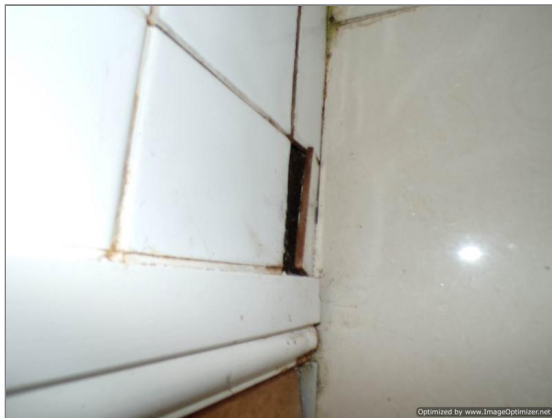
Photo - 173 Defects noted

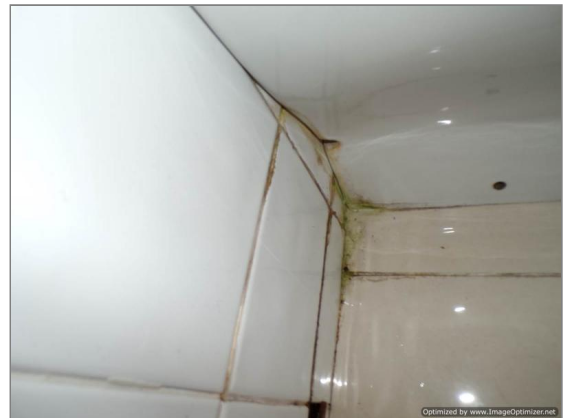
Photo - 174 Leak stains noted

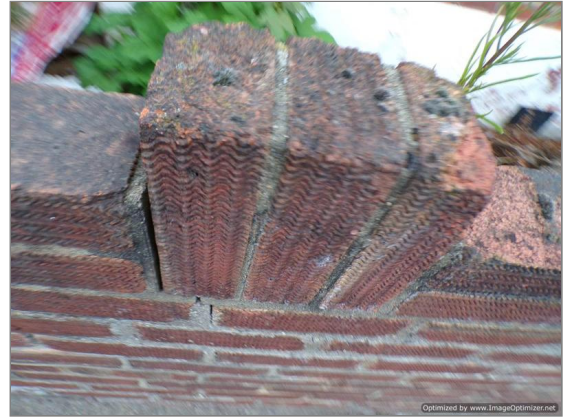
Photo - 184 Defects noted

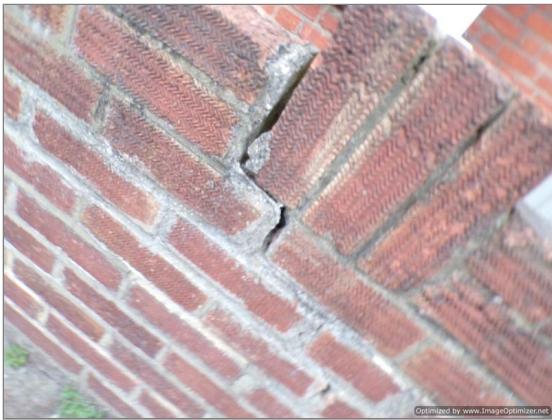
Photo - 189 Defects noted
