Your survey and valuation report

12 Harlestone Close
Luton
LU34DW

13th March 2024

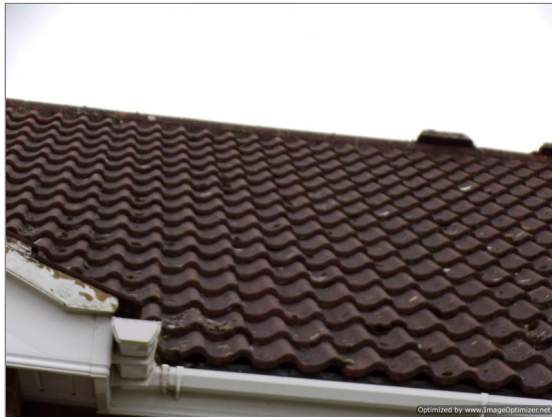
Photo - 2

Condition rating 2: Clear moss from roof surfaces/general repairs and maintenance required.

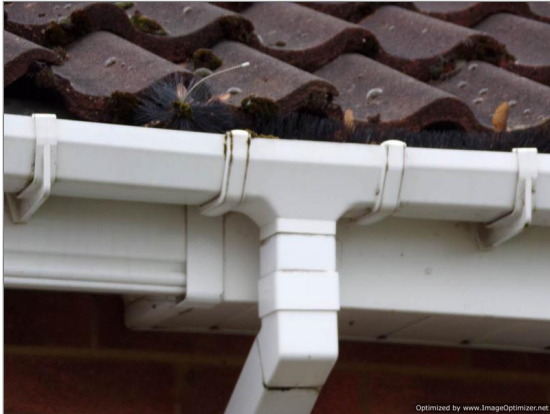
Photo - 11

Condition rating 2. Repair leaking PVC sections/general repairs and maintenance are required.

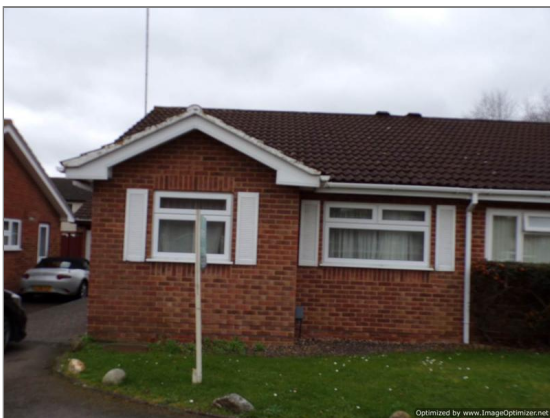
Photo - 17

Condition rating 3: Further specialist damp investigations/general repairs and maintenance required.

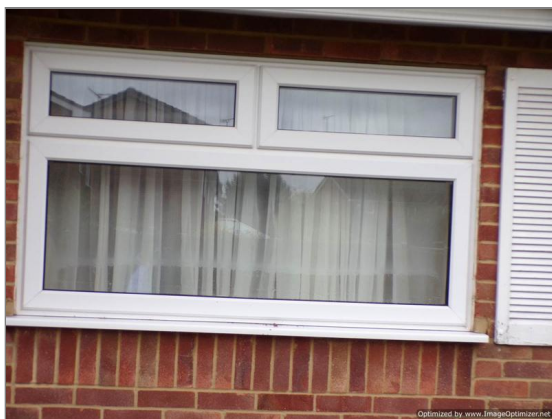
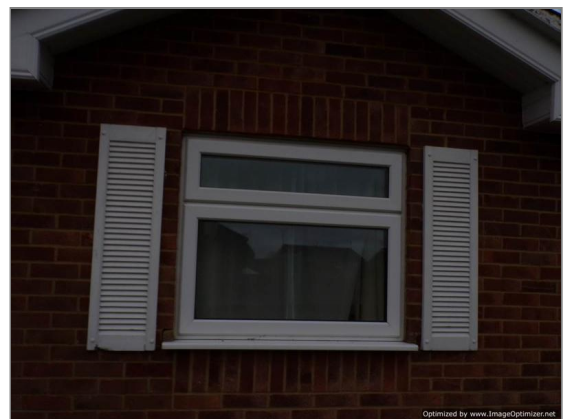
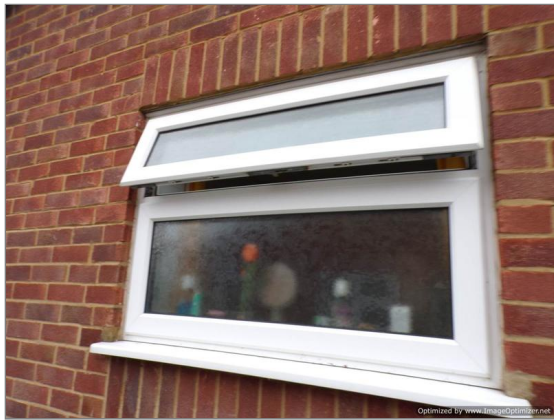
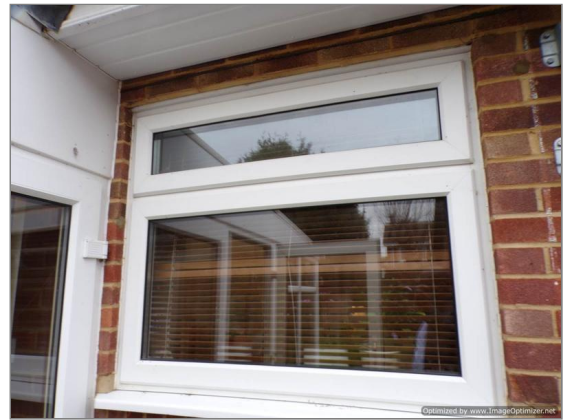
The junction between the window frames and the openings in the walls in which they are fitted has cracking. The crack should be filled, and the area should be regularly checked for cracks to prevent water ingress. The decorative finishes are weathered, with timber defect/chip/age-related marks noted. I would recommend maintenance/repairs to prevent timber decay.

Condition rating 2: General repairs and maintenance are required.

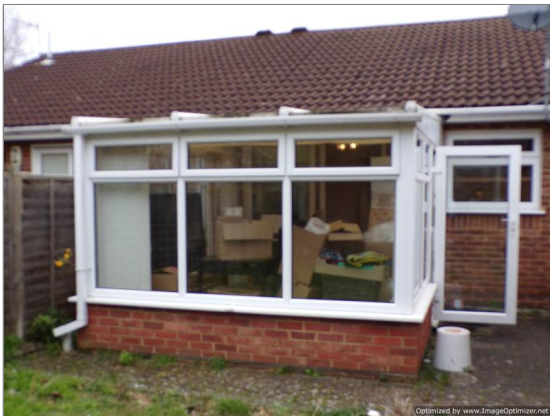
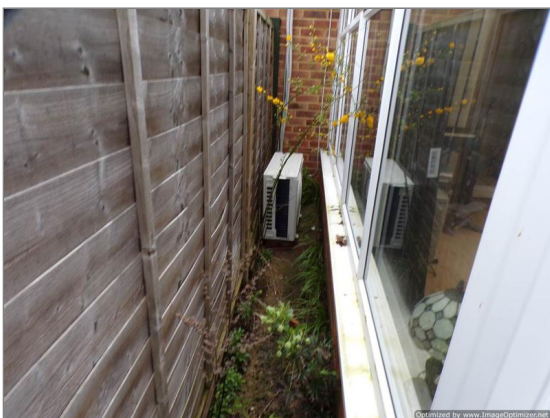
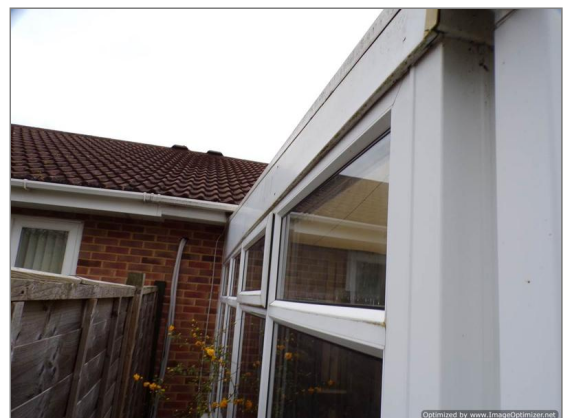
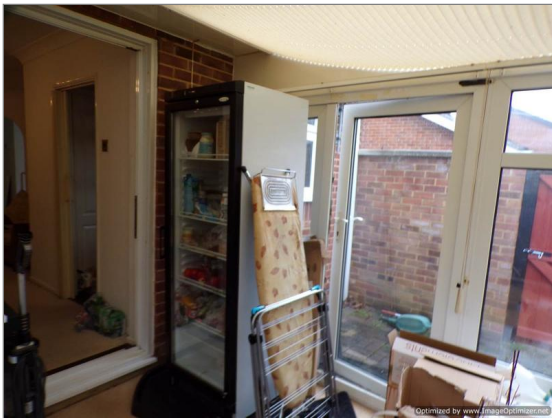
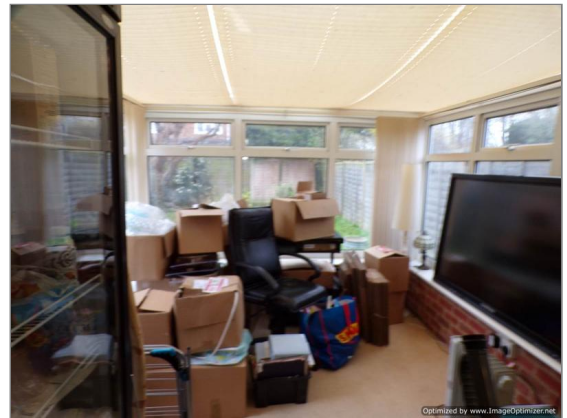
We noted defects/staining and recommended repairs.

Condition rating 2: General repairs and maintenance required.

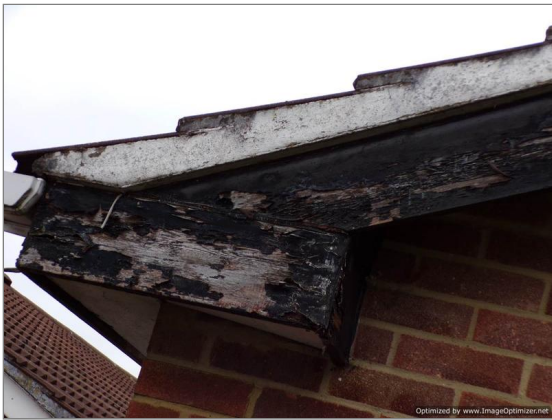
Photo - 37

The decorative finishes to the fascia, soffit boards/external joinery are weathered with evidence of timber defects noted. The external joinery have severely deteriorated and we you are advised to plan or budget for its replacement in the near future.

Condition rating 2 Repair external joinery/general repairs and maintenance required.

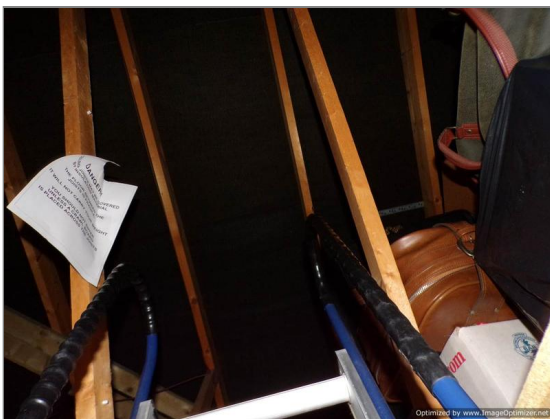
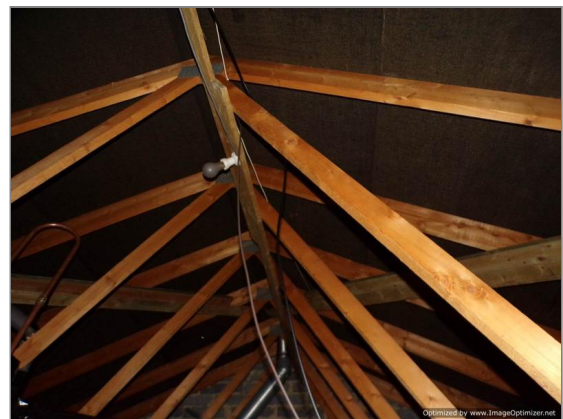
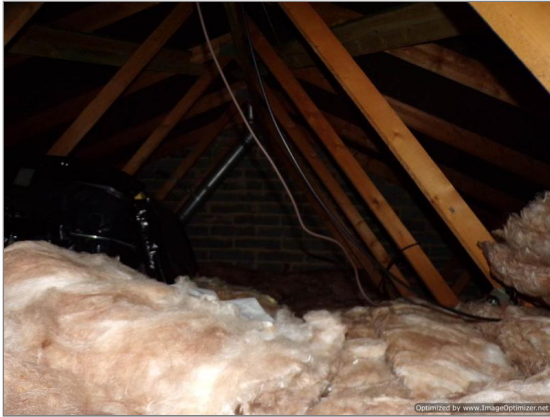
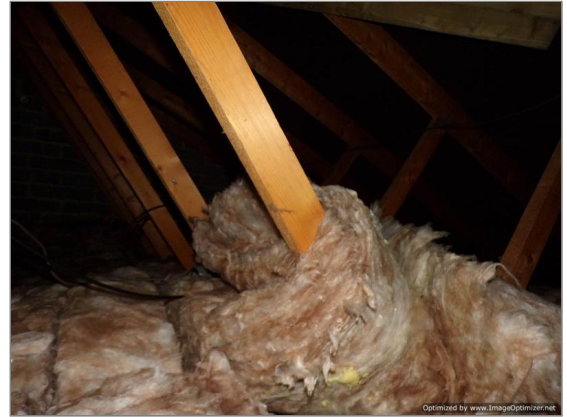
We observed possible concrete blockwork on the gable wall, and these have not been rendered. Concrete blocks have a shorter life than bricks, and your legal advisers should advise you further on the implications of this. No exposure has been undertaken, and our findings are therefore limited accordingly.

Condition rating 3: Further leak investigations and repairs required.

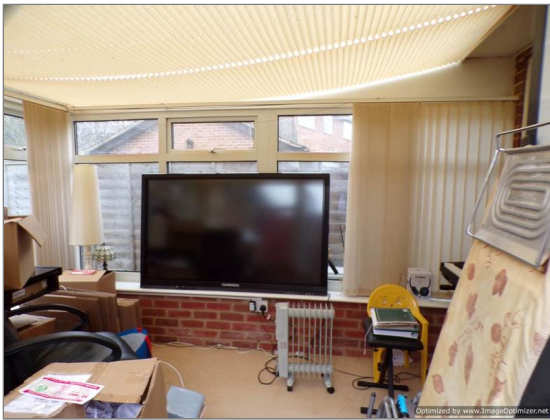
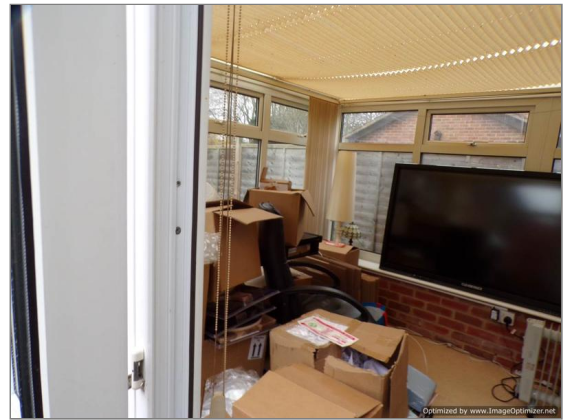
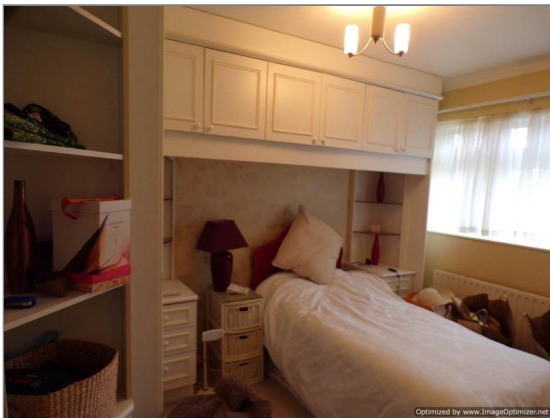
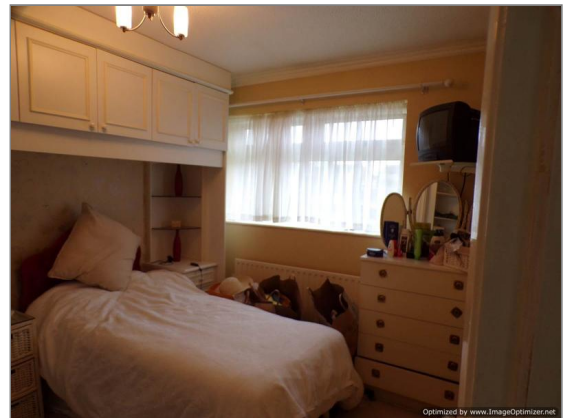
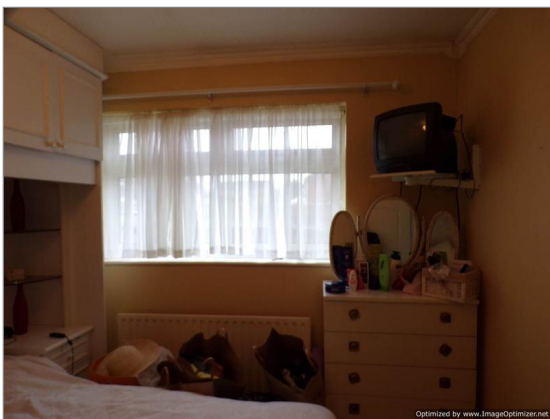
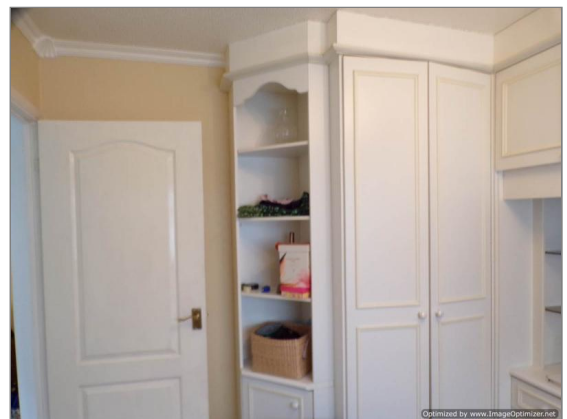
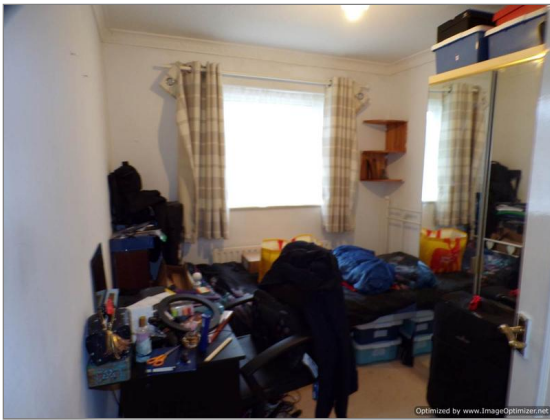
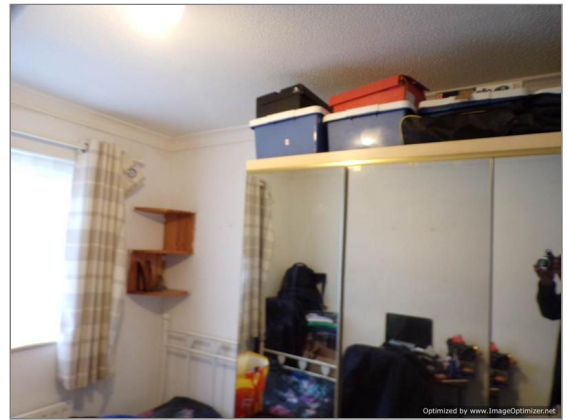
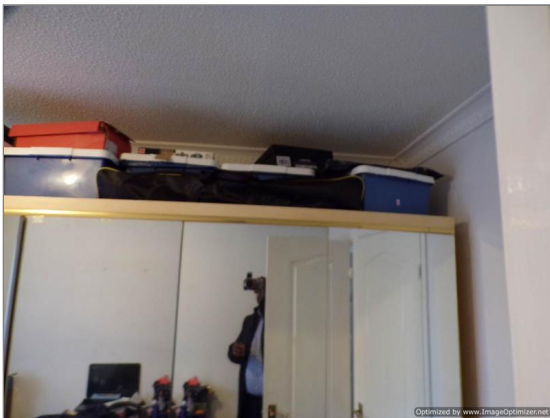
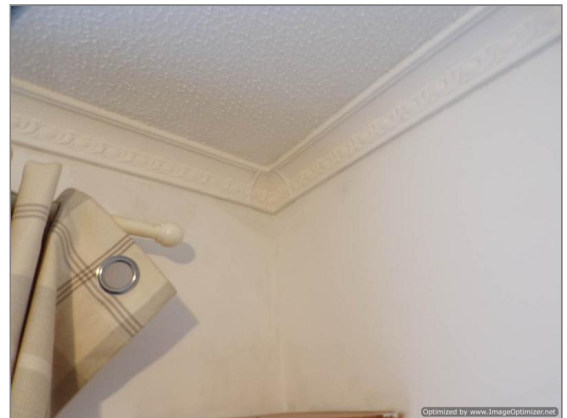
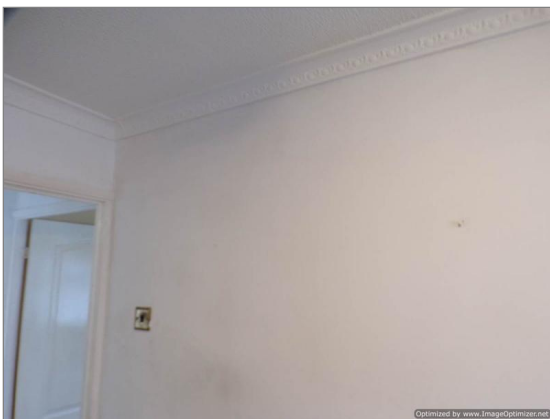
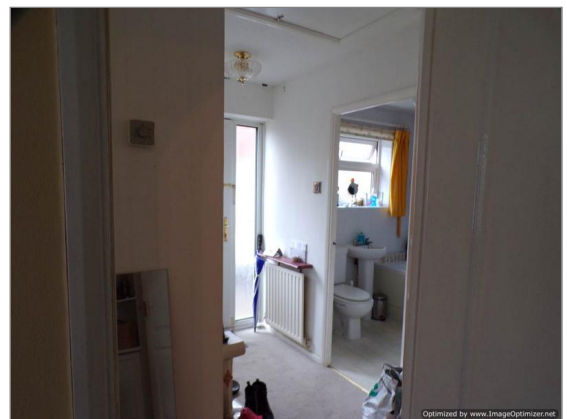
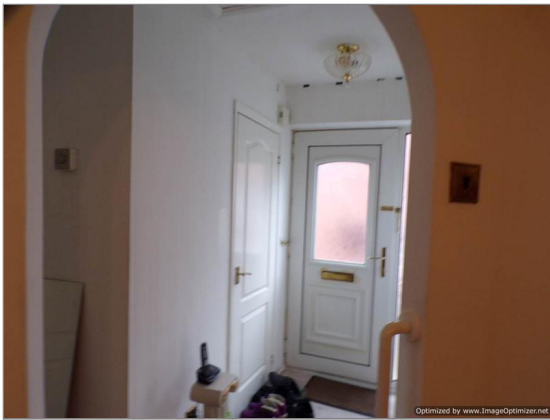
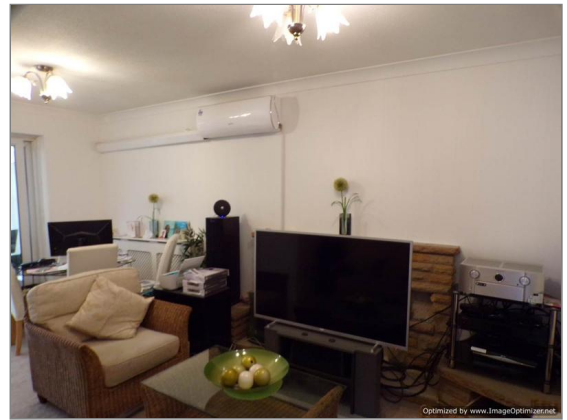
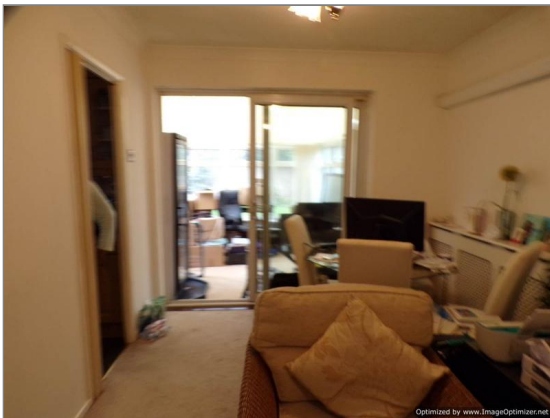
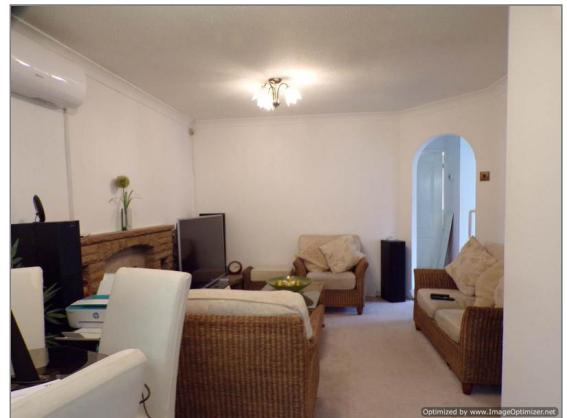
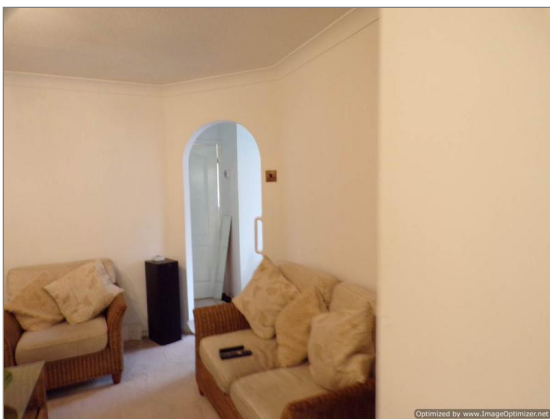
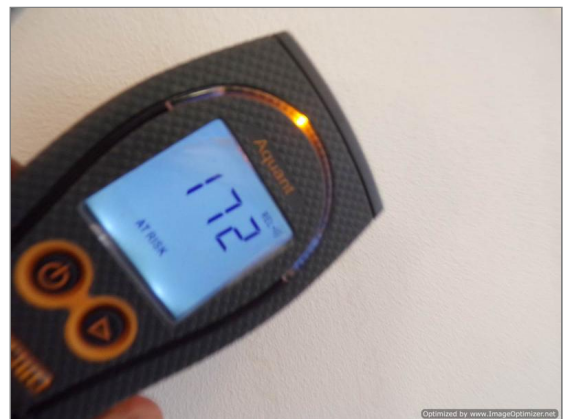
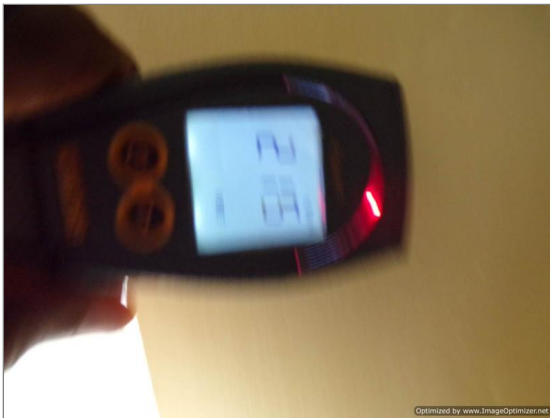
The floor is assumed to be concrete construction, overlaid with other fittings, and appeared in reasonable condition at the time of our inspection. Where walked on, it is firm underfoot and capable of bearing normal domestic load.

Floors generally of average finish and surface condition.

Since dampness has been noted, timber in contact with damp walls may have suffered decay/rot and further exposure and examination are recommended.

Condition rating 2: Further examination and repairs are required.

Concealed timbers are potentially suspected of woodworm attacks and fungal decay. We recommend that a reputable timber and damp specialist carry out further exposure and examination of sub-structural timbers prior to purchase commitment to more accurately determine their condition. Reports and quotations should be obtained from an appropriately qualified person prior to purchase commitment. It should be verified that the appropriately qualified person attending will be able to offer long-term insurance-backed validated guarantees on completion.

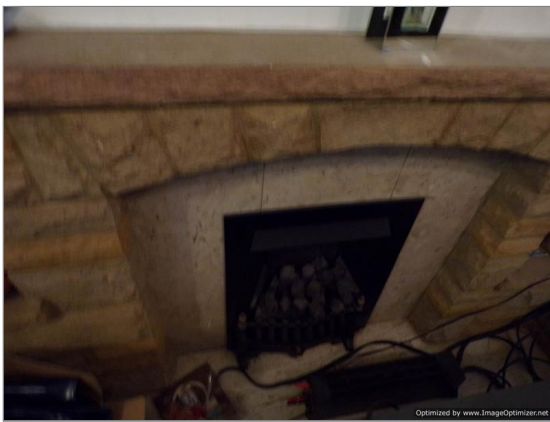
Photo - 83

The chimney breasts to the property are still in place fitted with a fireplace. These have not been tested and an appropriately qualified person should be called in prior to purchase commitment to fully determine the condition of this and all other gas appliances/pipework within the property to ensure their compliance with all regulations and requirements and the adequacy of flues to accommodate exhaust emission arrangements. 2

The central heating boiler is located within the utility cupboard. This appears in reasonable condition.

Condition rating 2: Test fireplaces.

A GAS SAFE registered engineer should be called in prior to purchase commitment to fully determine the condition of all gas appliances/pipework within the property to ensure their compliance with all regulations and requirements and the adequacy of the flue to accommodate exhaust emission arrangements. Please see our comment in Section I3 Risks

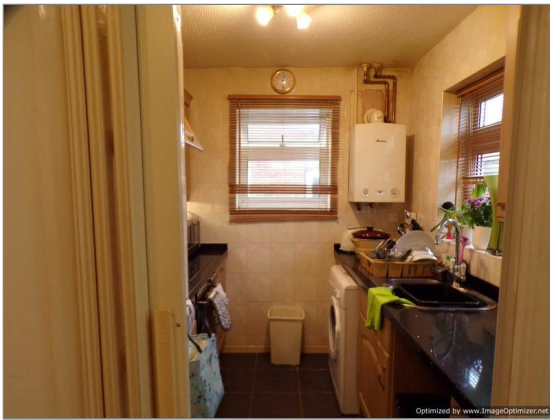
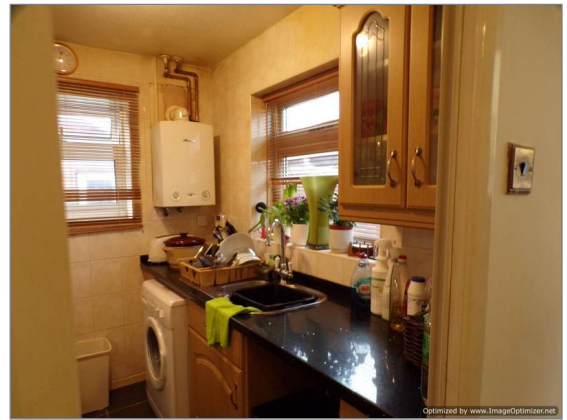
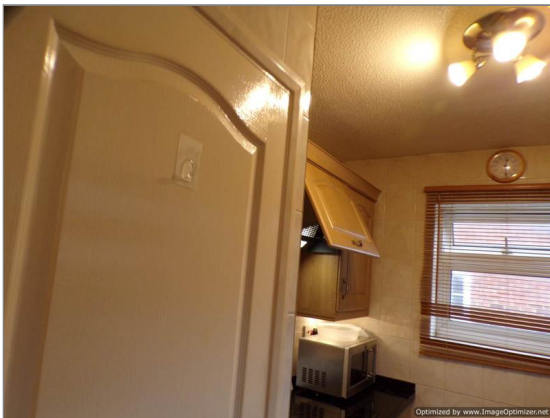
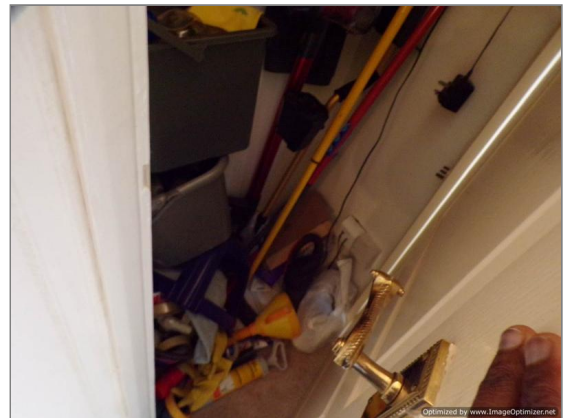
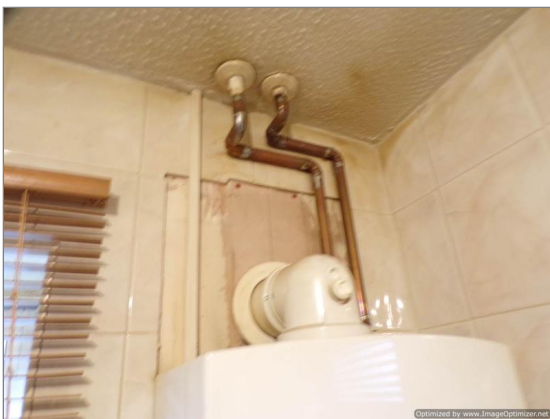
Kitchen fittings comprise a range of relatively old base and wall units of timber construction. Kitchen fittings are serviceable but were not inspected in detail, some wear and tear and minor repairs should be expected.

Kitchen sink, washing machine etc., assumed plumbed in plastic/copper. Suitability of pipe connections and waste not readily ascertained. We noted missing wall tiles/defects and recommend repairs.

Condition rating 2: General repairs and maintenance are required.

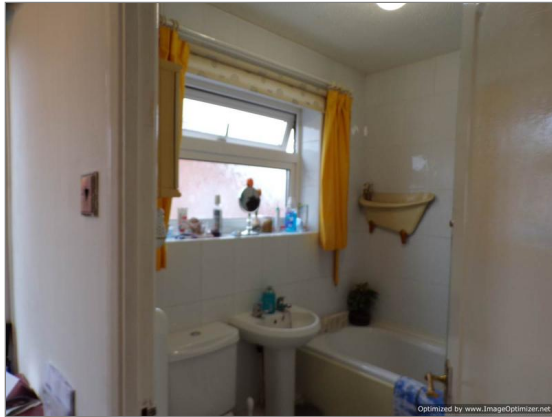
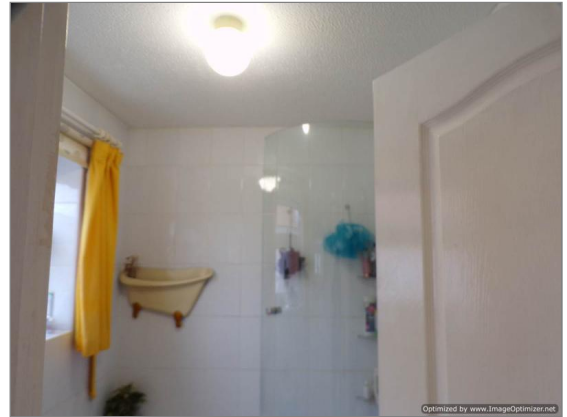
Condition rating 3: Further leak investigations/general repairs and maintenance are now required.

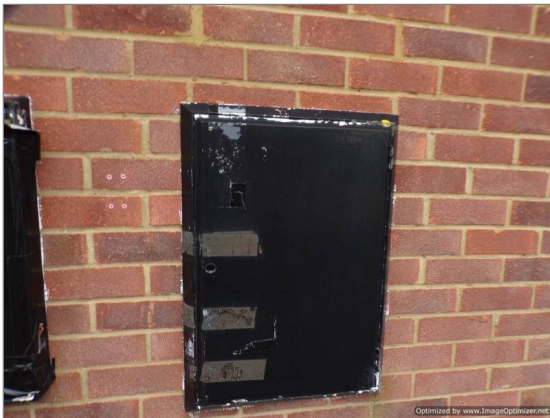
Photo - 97

A mains gas supply is installed, and the meter is located in a consumer box outside the property. Where observed, the copper pipework appears to be in satisfactory condition. No smell of gas was detected during our inspection and no other defects were noted that require urgent or significant repairs to the installation.

However, in view of the complexity of regulation and safety implications and the lack of evidence of adequate maintenance, we recommend an inspection of the installation and appliances, etc., by the appropriate gas company prior to future use.

It should be noted that all alterations or installation of pipework must be carried out by registered 'Gas Safe' contractors. You are advised to obtain a report and quotation from a Gas Safe registered engineer in respect of gas installations on the property.

Condition rating 3: Test gas installations and appliances.

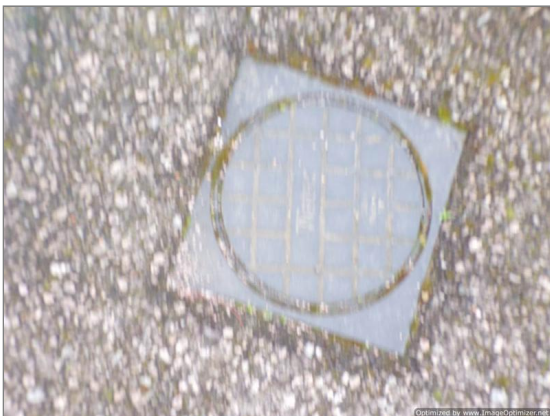
Photo - 98

The property is considered plumbed in plastic/copper, the suitability of pipe runs, spacing, clipping, and jointing are not readily determined. There was no obvious evidence of a defect noted at the time of our inspection. However, it is recommended that a qualified plumber should be instructed to report on the condition of all pipes, including the concealed ones.

We have not tested the plumbing connections, and we recommend further inspection by a qualified plumber to verify whether there is any lead pipe to the main supply.

Condition rating 3: Test plumbing connections

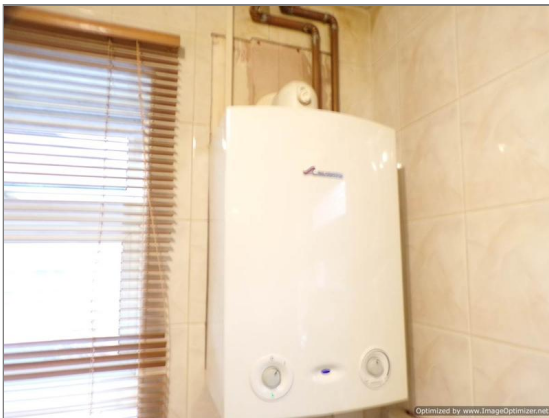
Photo - 99

The boiler is connected to radiators, and the radiator valves, room thermostats, and boiler managers are in reasonable condition; however, we cannot comment on their serviceability.

The boiler is fitted with a balanced flue which discharges to the outside air through the external wall. The flue appears clear and unobstructed and should be provided with a protective guard to prevent injury and damage.

The central heating system was not tested. We recommend a test before purchase commitment by an appropriately qualified person to be categoric regarding the conditions under variable operational requirements.

Condition rating 3: Test heating services

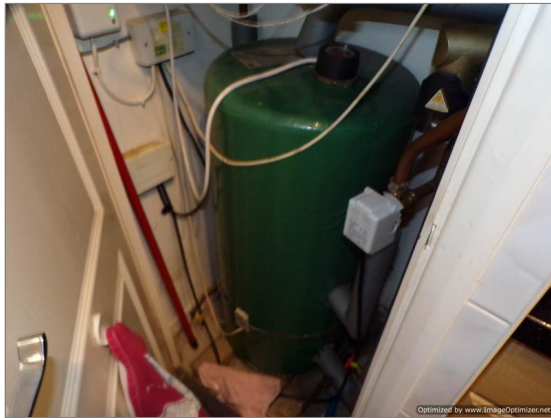
Photo - 100

Domestic hot water is provided by the central heating boiler and then stored in a pre-lagged copper cylinder located within the boiler cupboard. The cylinder appears to be in reasonable condition, showing no evidence of leakage. However, further leak checks should be undertaken before commitment to purchase. The efficiency and life span of the boiler and the pressurized hot water

The cylinder has an immersion heater thereto and appears in reasonable condition. The suitability of hot water distribution is not readily ascertained, generally copper supply pipework distribution. We cannot confirm whether the system is currently covered by a service/maintenance contract.

It is recommended that service records be obtained, and if the boiler has not been serviced recently, an appropriately qualified person should be instructed to undertake a full service, including checking the ventilation to the boiler in addition to checking and cleaning out the flues as found to be necessary.

Condition rating 3: A test is required.

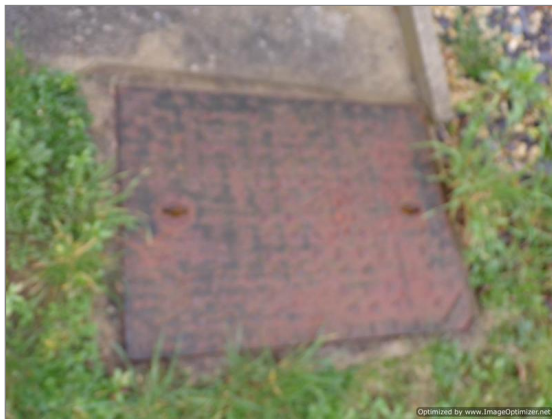
Photo - 102

PVC/Cast iron soil and vent pipe to the rear of the building are in reasonable condition to type and age, but regular maintenance will be required.

Drainage gullies should be cleaned and maintained on a regular basis to minimise the risk of blockage, and as a precaution, all surface water gullies and drainage trenches within curtilage should be flooded before purchase commitment to determine their likely adequacy or otherwise under simulated storm conditions.

Condition rating 3. Check the drainage system.
