Your survey report

74 Kenlor Road
London
SW17 0DF

2nd September 2024

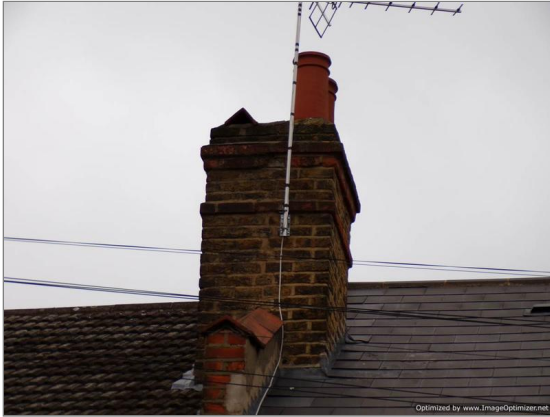
Photo - 2

Condition rating 3: Further leak investigations, cap chimney pots/general repairs and maintenance required.

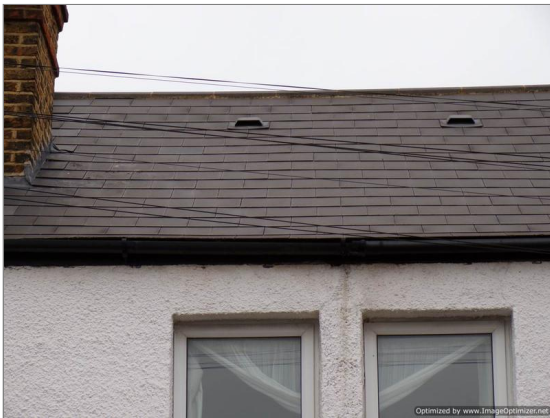
Photo - 5

Condition rating 3: Further roof/leak investigations/general repairs and maintenance are required.

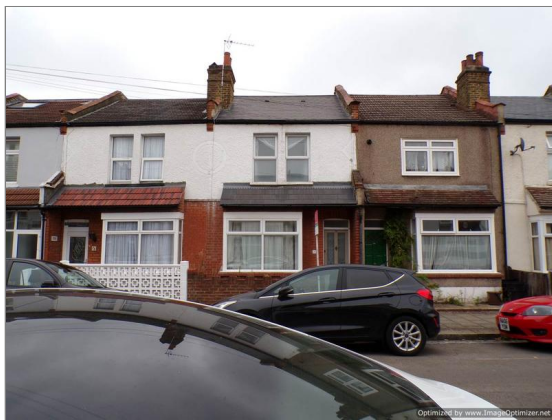
Photo - 26

Condition rating 3: Further specialist damp,leak, structural engineers investigations/general repairs and maintenance are now required.

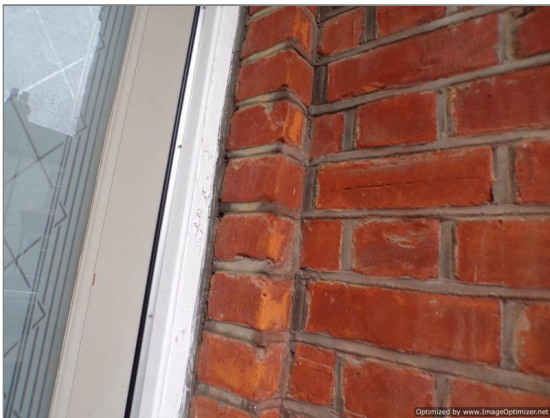
Photo - 36 Modern pointing

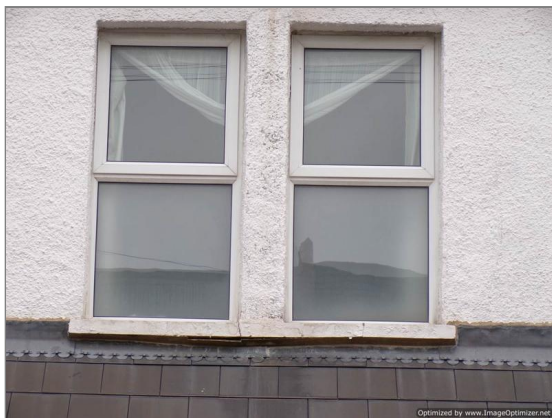
Photo - 42

Condition rating 3: Further leak investigations/general repairs and maintenance are required.

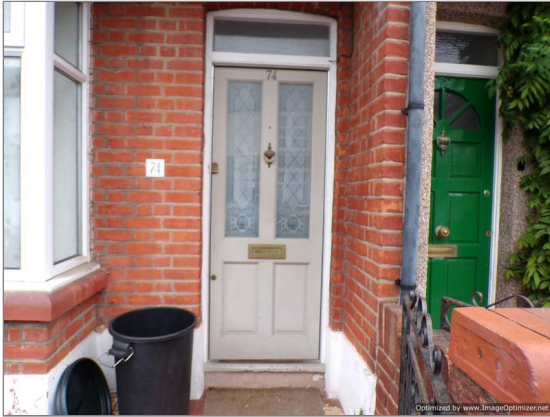
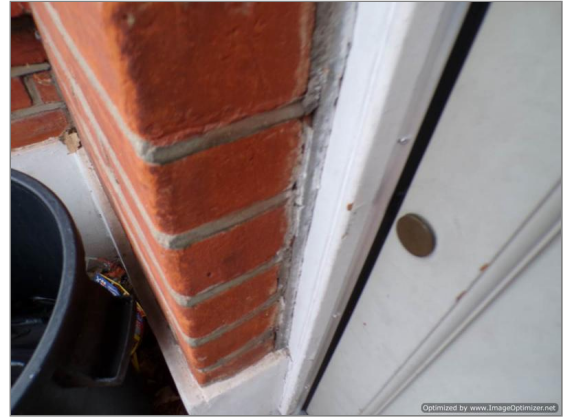
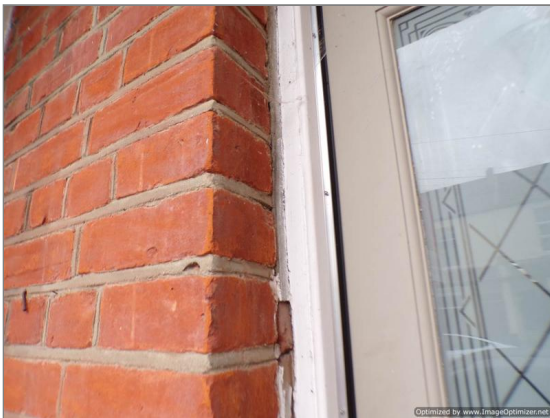
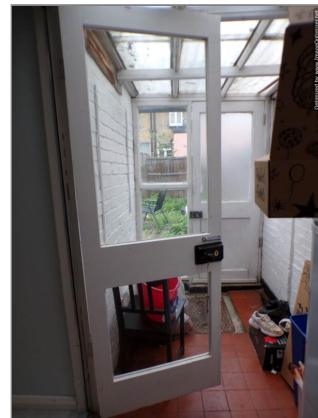
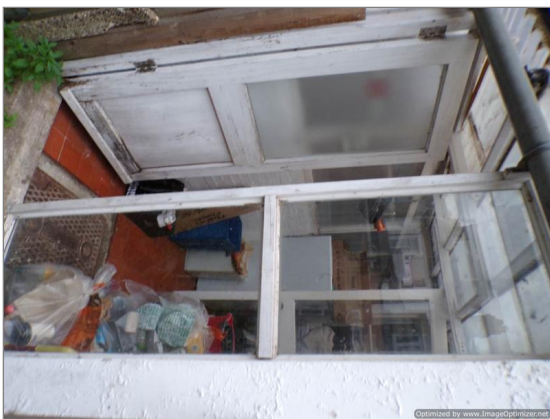
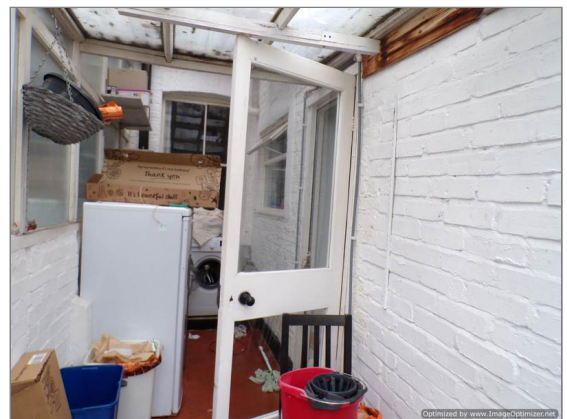
The main entrance door is of timber construction with side screens. The door and frame are found to be in average condition at the time of our inspection with cracking/defects noted to the sides of the door and we recommend repairs. The doors leading to the conservatory/rear garden are of timber frame construction and appears in poor condition. Evidence of weathering/timber defects were noted and we recommend repairs.

Condition rating 2: General repairs and maintenance are now required.

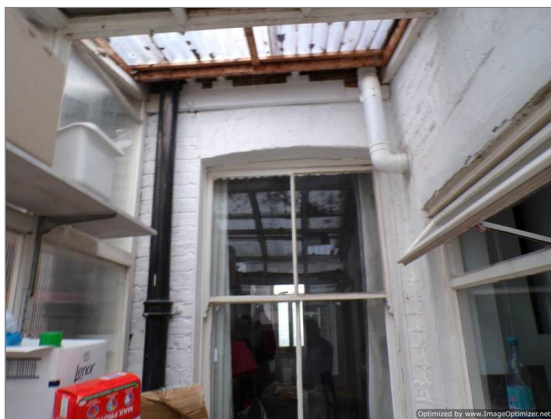
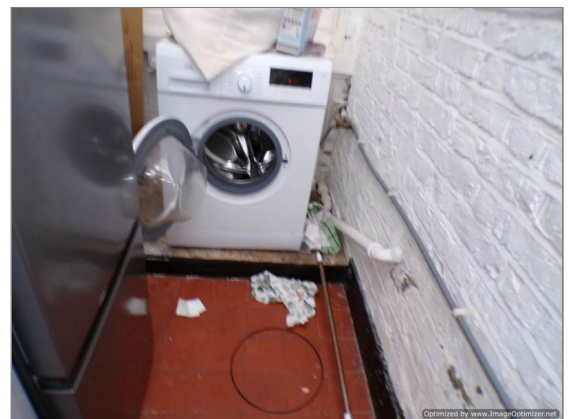
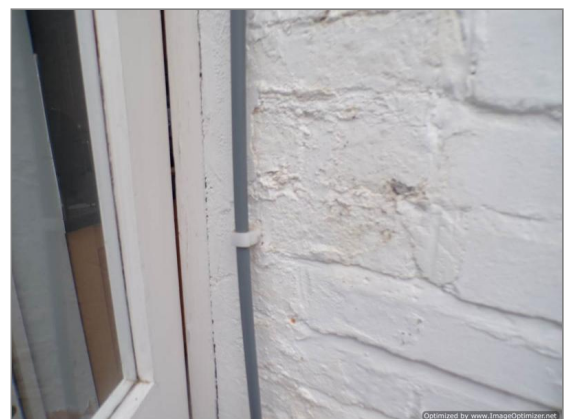
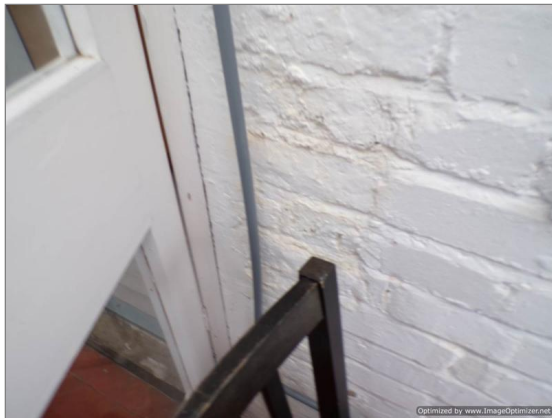
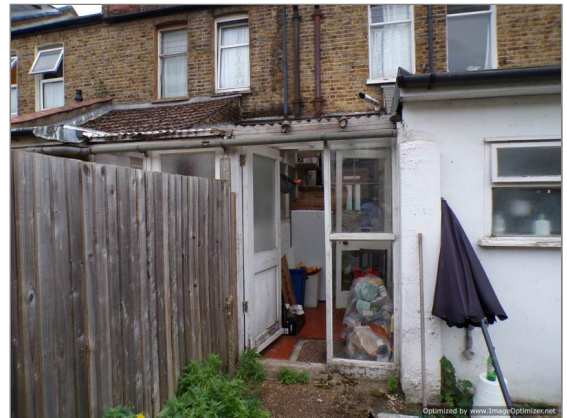
There is a conservatory to the rear/side of the building. Conservatories are not required to be built to the same exacting standards as dwellings, and therefore, cannot be expected to function or last as well. The conservatory is old and replacement is recommended in the fullness of time.

The rear exit door from the timber-framed conservatory is timber-framed. Evidence of weathering and early onset of decay was noted to the door and replacement will be required. When the door is replaced, the decorative finish should be regularly maintained to prevent decay.

The roof covering comprises lightweight construction and care should be taken when gaining access for maintenance. The polycarbonate sheet roofing together with its seals will deteriorate and should only be regarded as a short-lived form of roof, prone to problems of leakage and condensation. Evidence of significant leak staining and dampness was recorded within the conservatory and further ;leak/damp investigations are now required.

Condition rating 3: Replace conservatory/further leak/damp investigations/general repairs and maintenance are required.

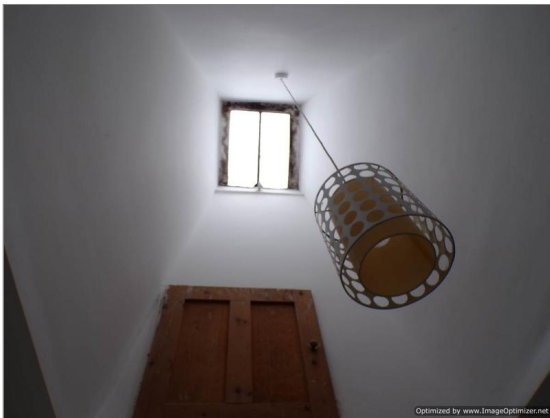
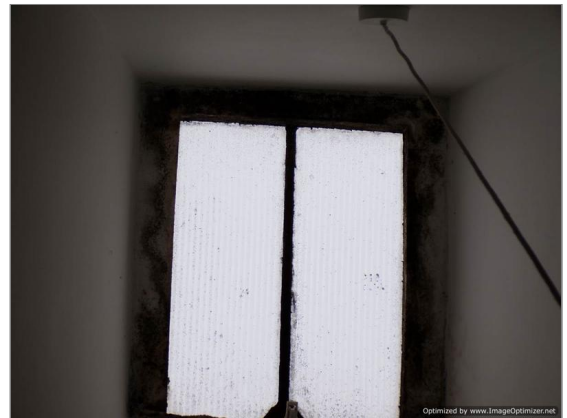
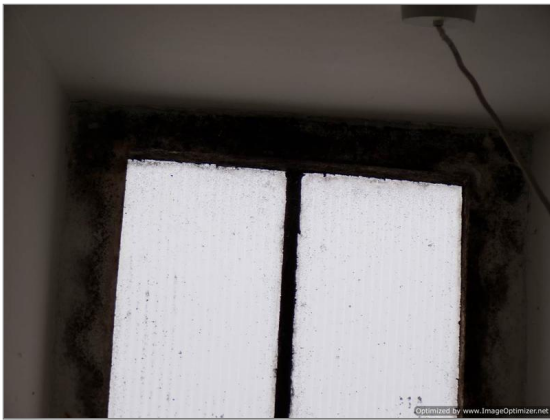
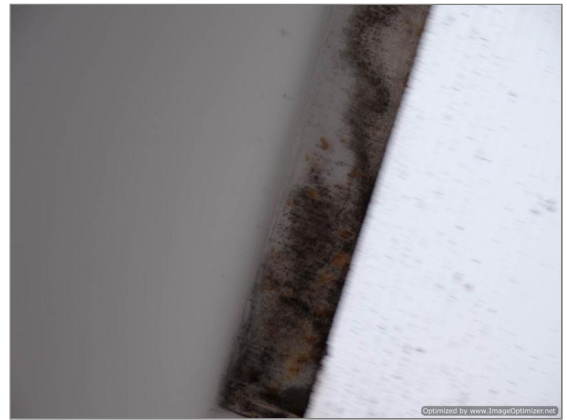
Condition rating 3: Further leak investigations/general repairs and maintenance are required.

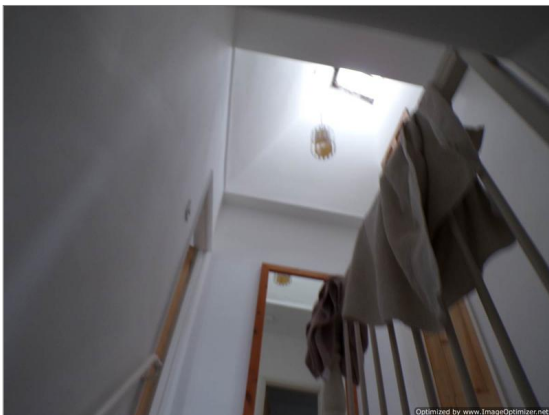
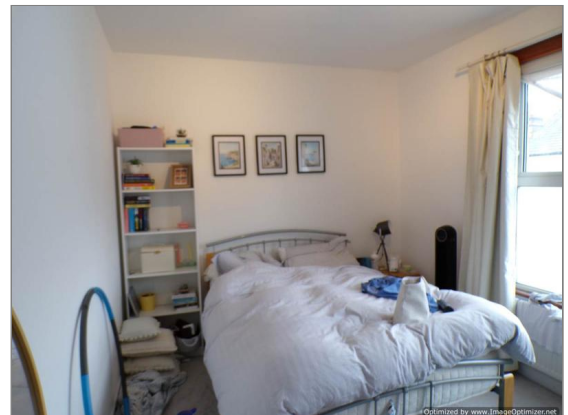
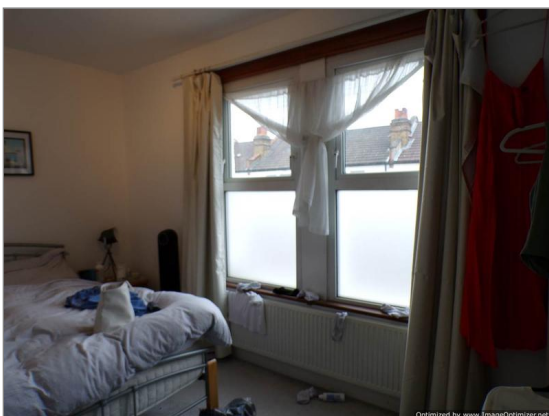
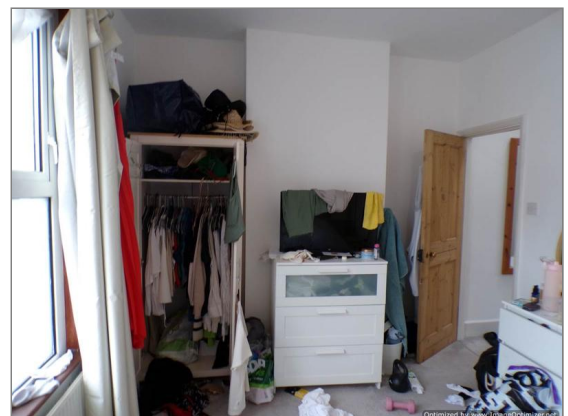
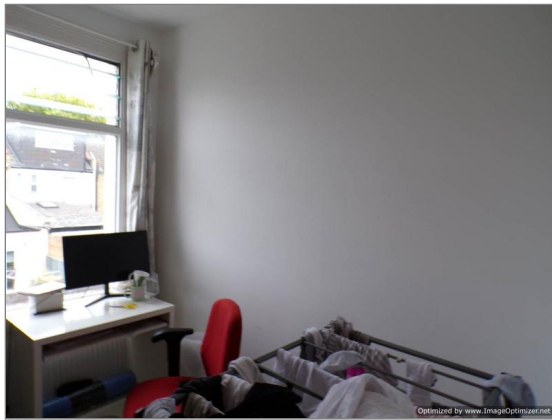
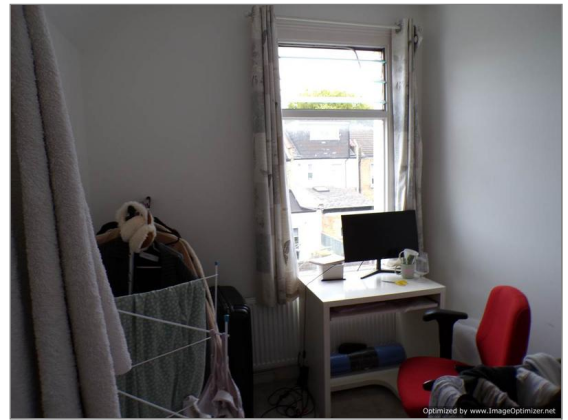
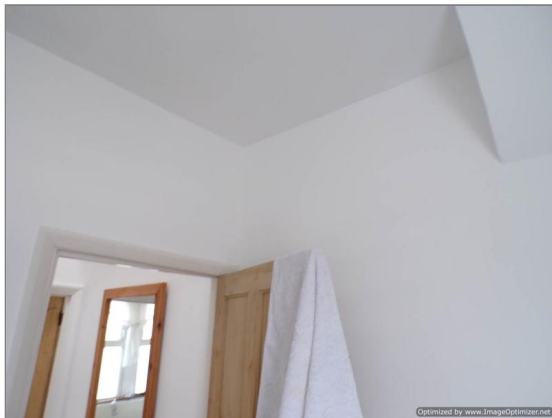
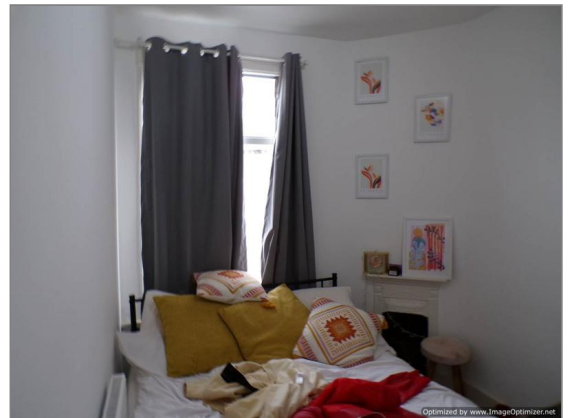
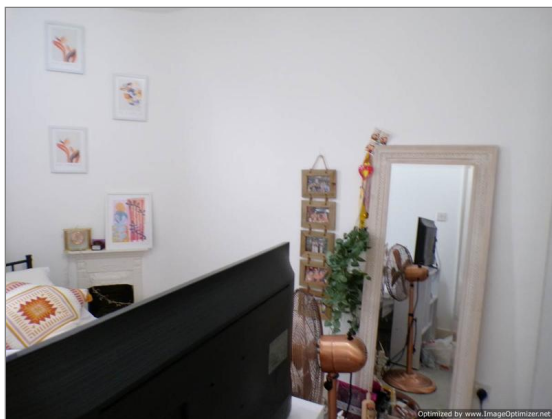
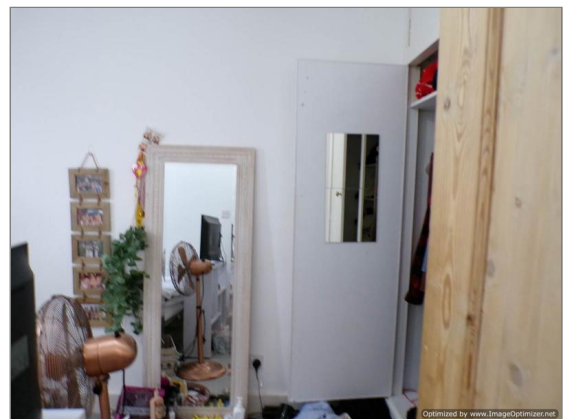
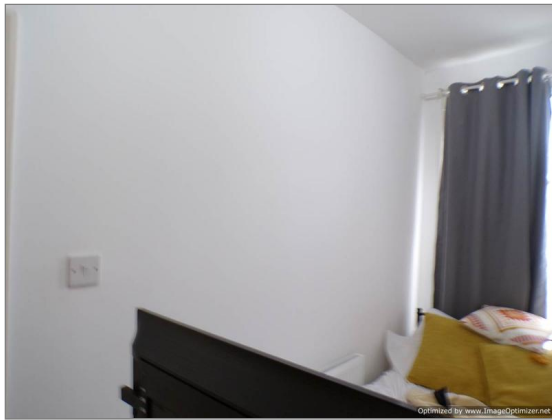
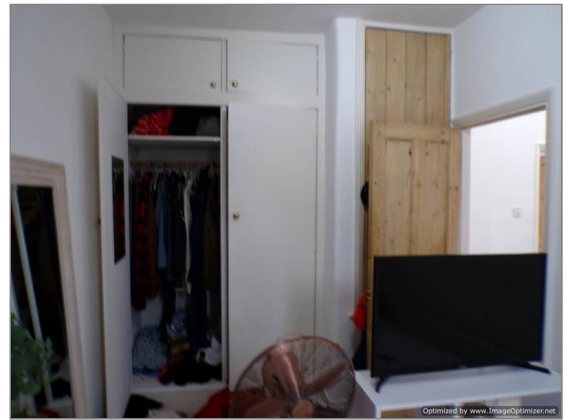
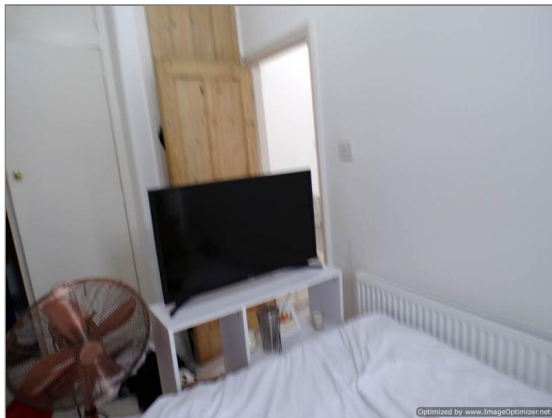
However, there are signs that the property has been affected by past settlement as evidenced by cracking to wall surfaces around openings. We recommend further structural engineers investigations and repairs. Long-term monitoring would, of course, be necessary to be categorical regarding the structural condition but is not considered warranted on the basis of our single inspection within the limitations imposed.

Evidence of leak staining was noted on some of the walls in the rear bedrooms wall surfaces. Some of these surfaces we assume were wet and causing damage and further action is recommended. Your legal advisors should make further enquiries with the vendors in respect of the staining and confirm whether any valid guarantees still exist for repair work which may have been undertaken.

Condition rating 3: Further investigations/general repairs and maintenance are now required.

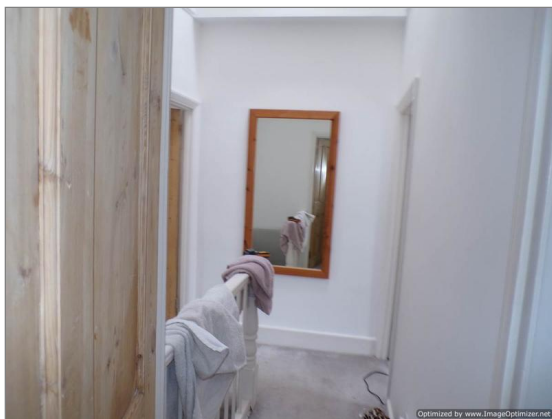
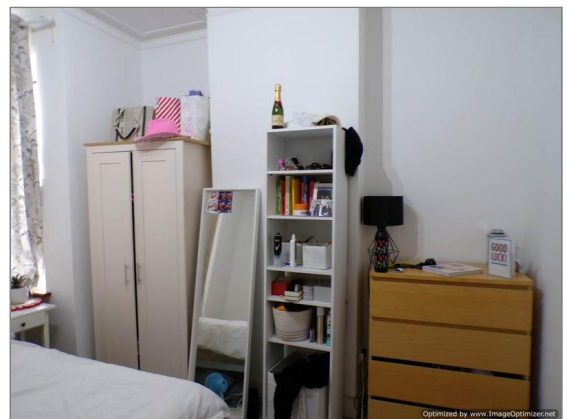
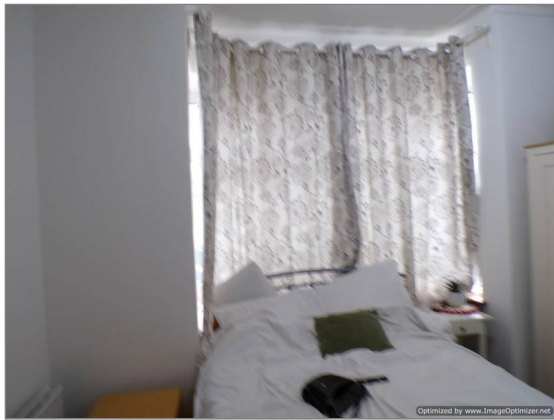
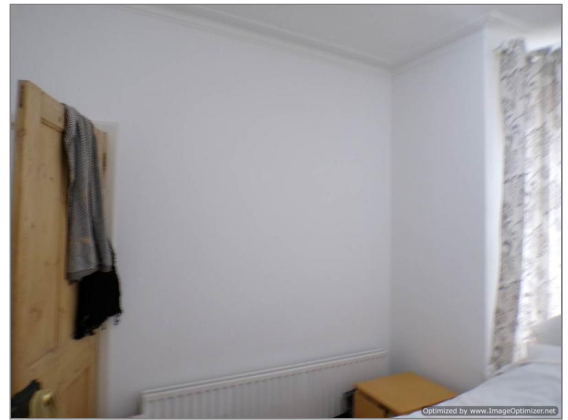
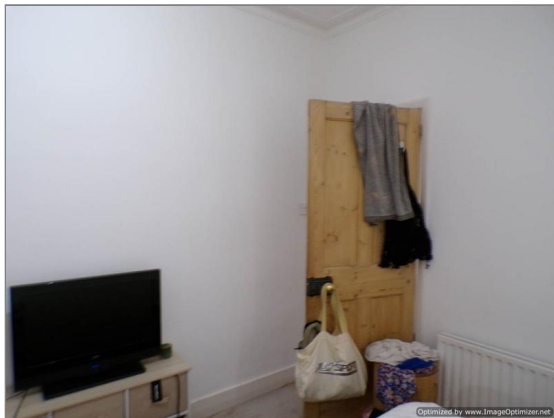
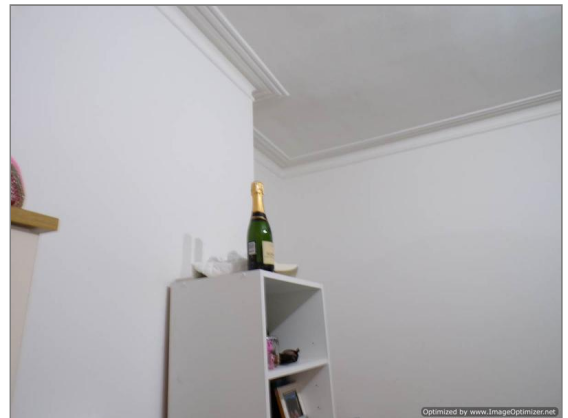
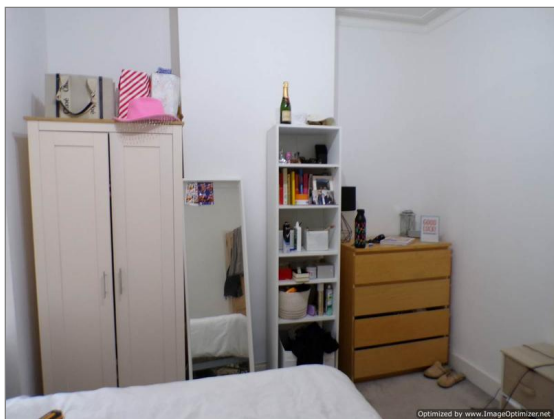
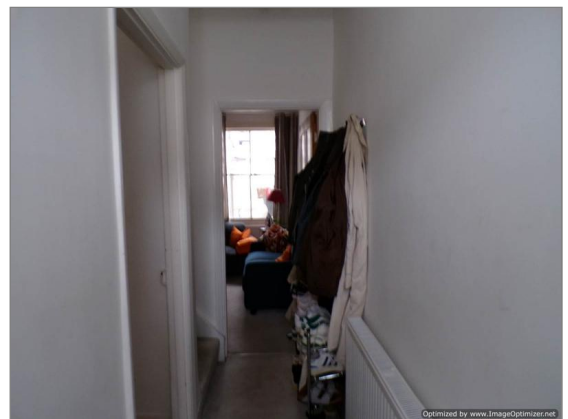
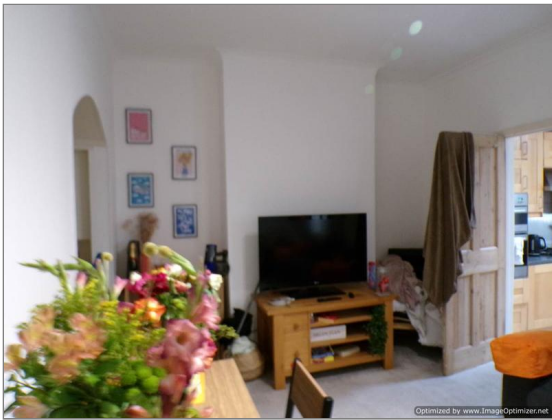
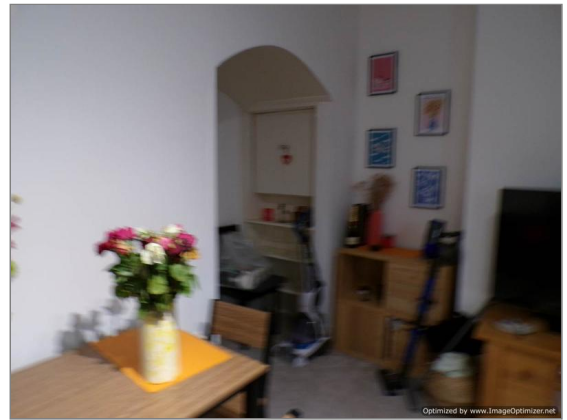
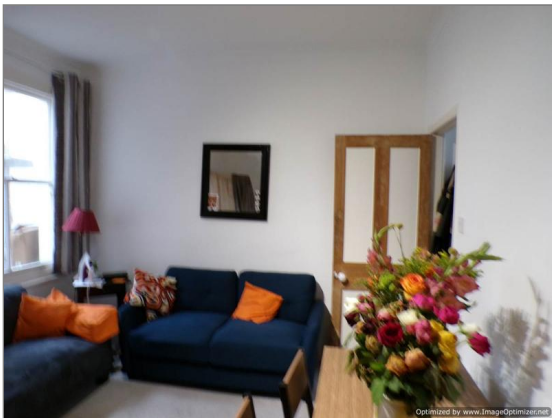
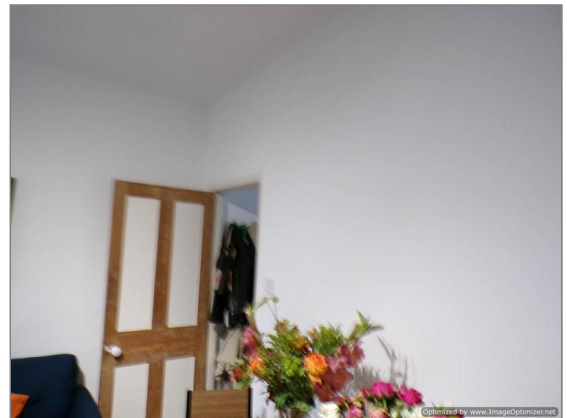
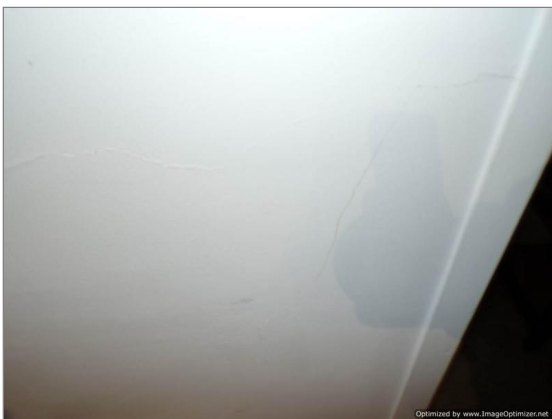
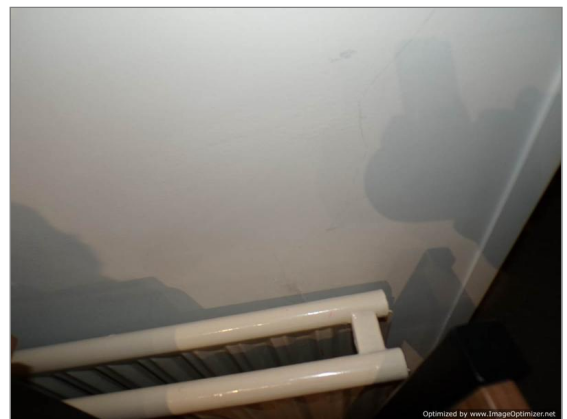
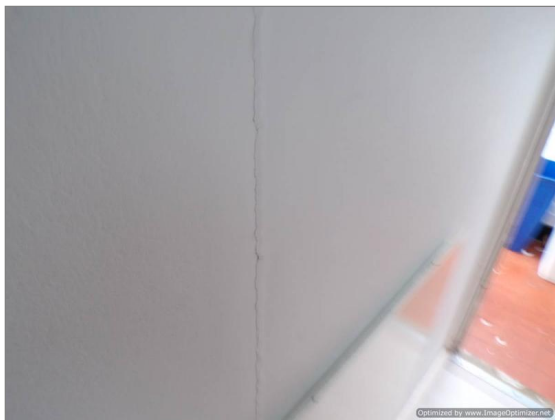
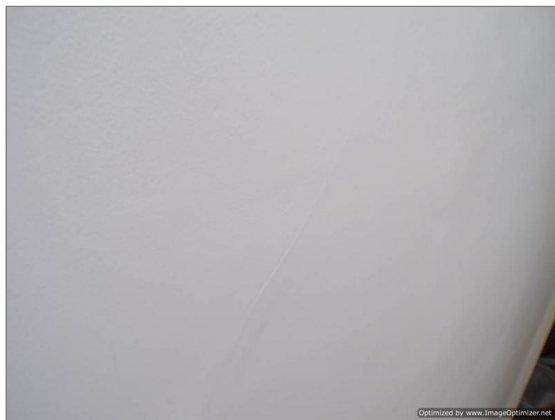
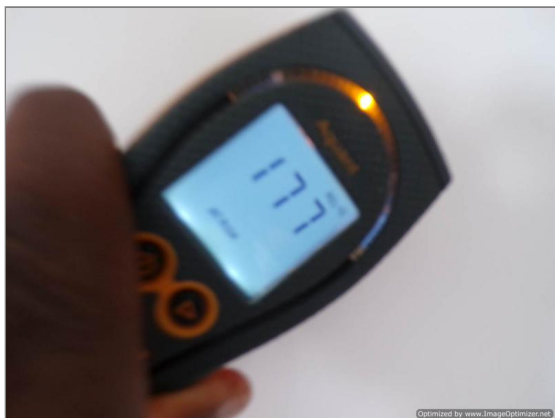
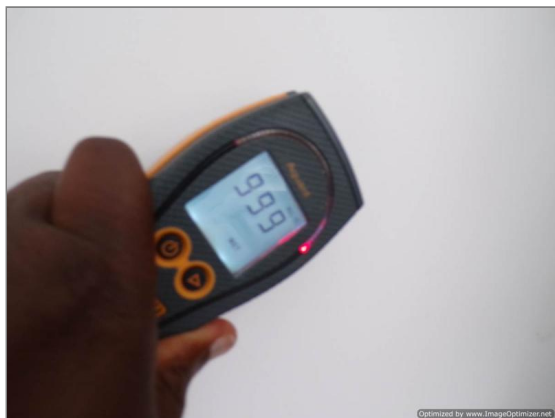
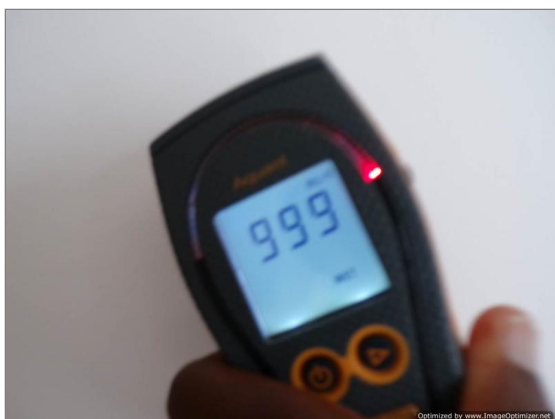
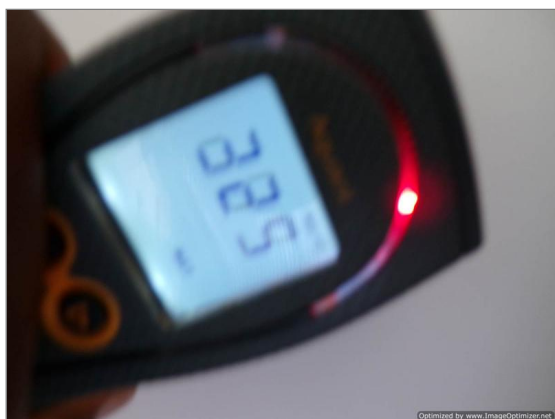
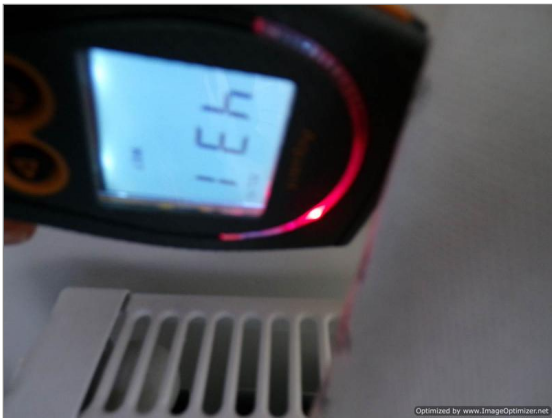
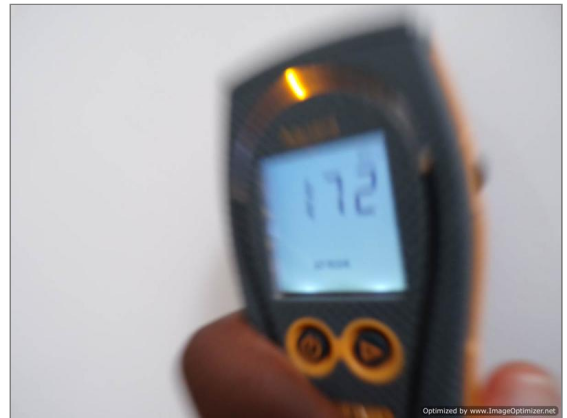
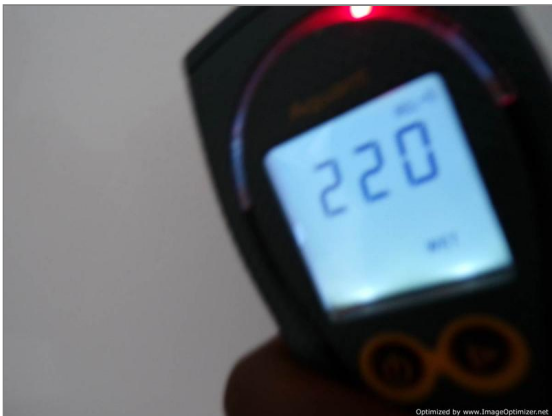
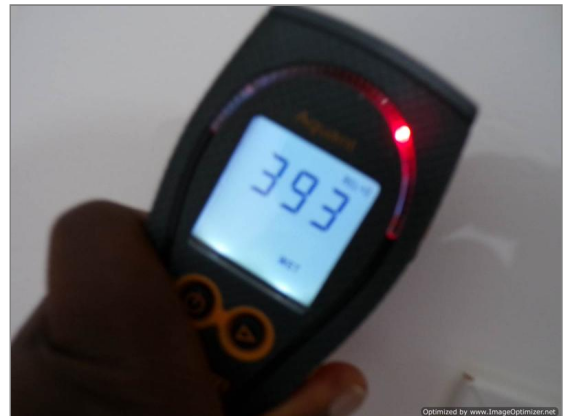
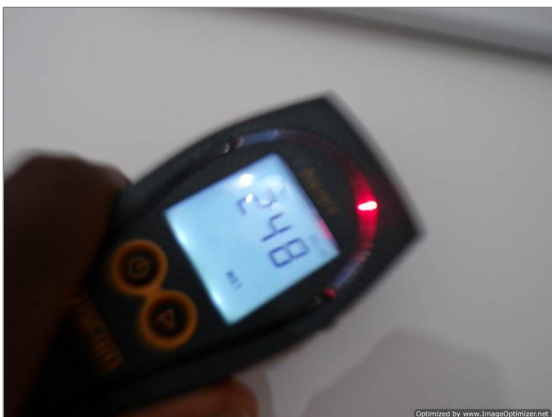
Photo - 116 Evidence of a possible structural movement/
defect/leak stains noted

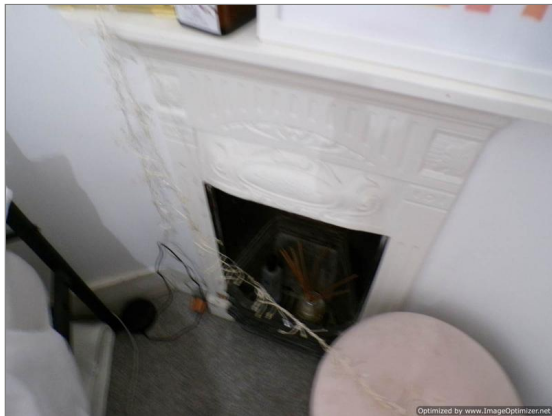
Photo - 156

The chimney breasts to the property are still in place, a fitted with fireplace. These have not been tested, and an appropriately qualified person should be called in before purchase commitment to determine the condition of this fully and all other gas appliances/pipework within the property to ensure their compliance with all regulations and requirements and the adequacy of flues to accommodate exhaust emission arrangements. 2

If you intend to use this as a working fireplace, it should be noted that the flue lining in a property of this age would have perished and needs repair or replacement. A chimney sweep should also be required to ensure the chimney is properly swept to prevent a fire hazard.

The central heating boiler is located within the utility cupboard. This appears to be in reasonable condition.

Condition rating 2: Test fireplaces.

A GAS SAFE registered engineer should be called in before purchase commitment to fully determine the condition of all gas appliances/pipework within the property to ensure their compliance with all regulations and requirements and the adequacy of the flue to accommodate exhaust emission arrangements. Please see our comment in Section I3, Risks.

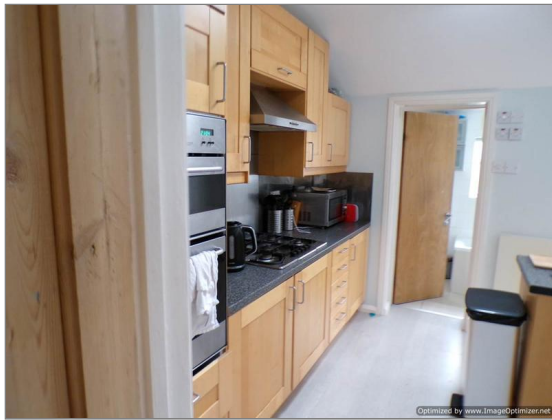
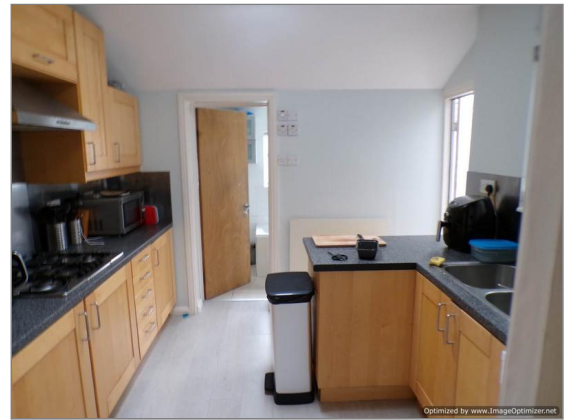
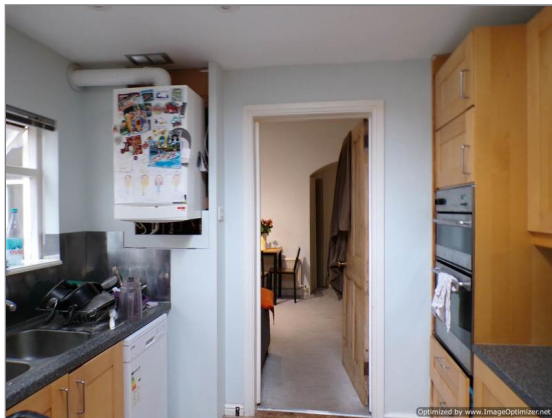
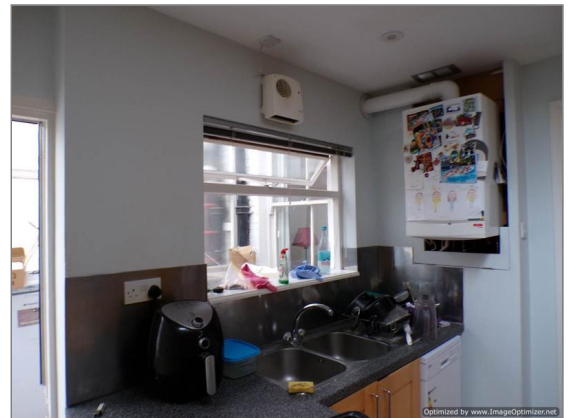
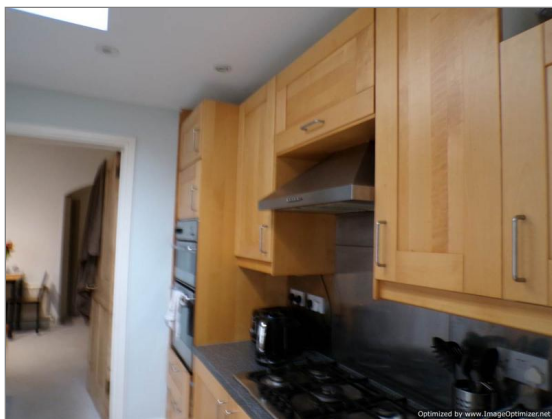
Kitchen fittings comprise a range of relatively old base and wall units of timber construction. They are of reasonable quality and in reasonable condition for their type and age. The standard of fitment is a matter of personal taste.

We noted evidence of dampness in the kitchen and further investigation is now required. Please see D4 and E3 for further comments.

Condition rating 3: Further specialist damp investigation/general repairs and maintenance required.

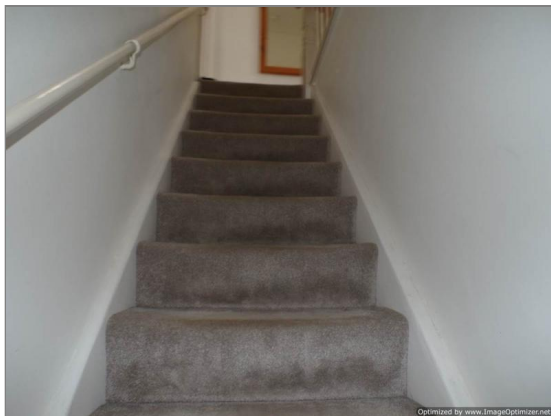
Photo - 162

Internal joinery includes the skirting boards, architraves, and timber-framed doors. It is generally in reasonable condition for its type and age, and some cosmetic work to finish it is required.

From random sampling, some open and closed doors operated freely and were generally in satisfactory condition. Internal joinery is in reasonable condition, and the possibility of concealed defects could not be ruled out.

Condition rating 1. No repair is required at the time of our inspection. The property should be maintained in the usual way.

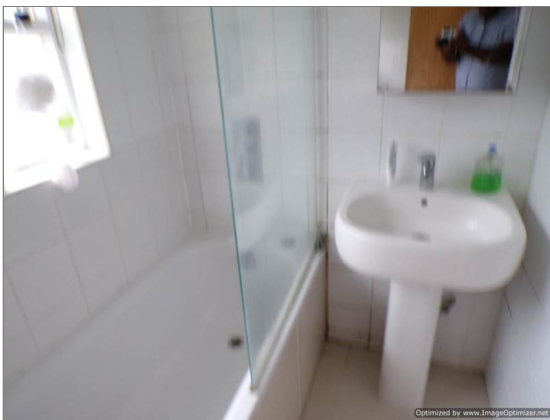
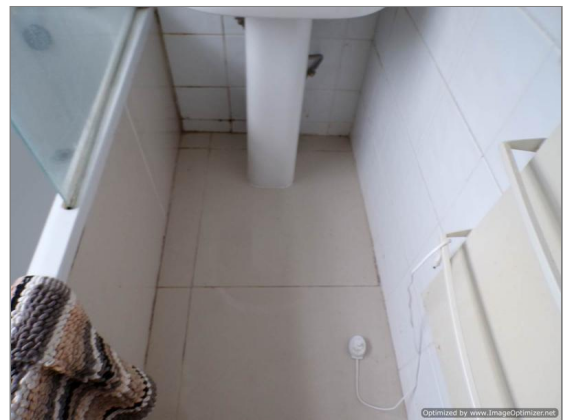
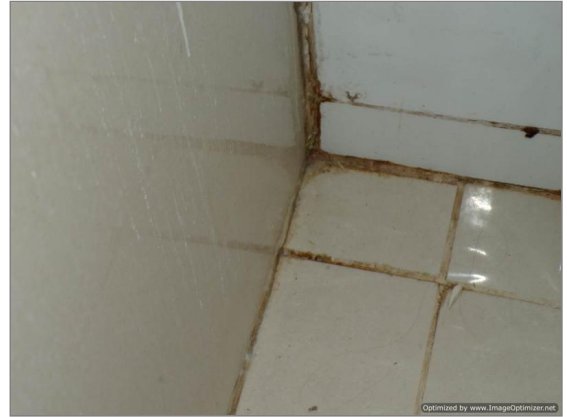
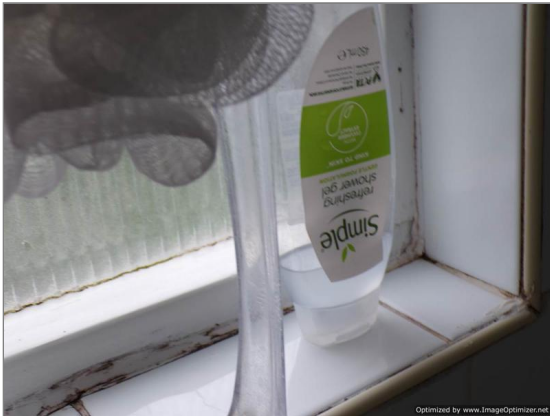
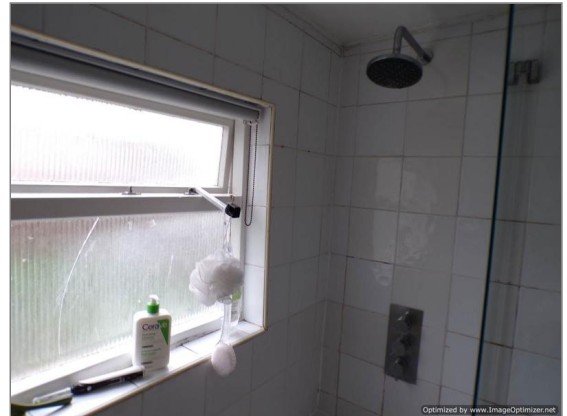
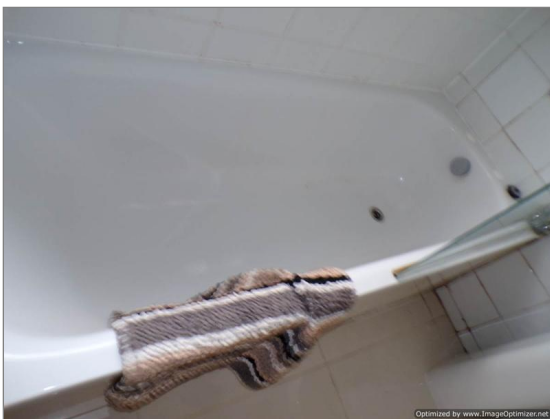
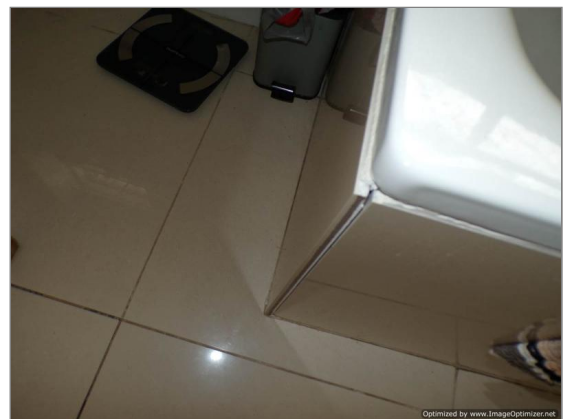
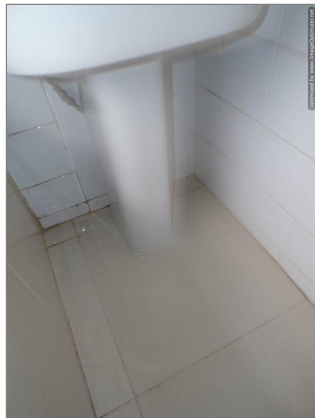
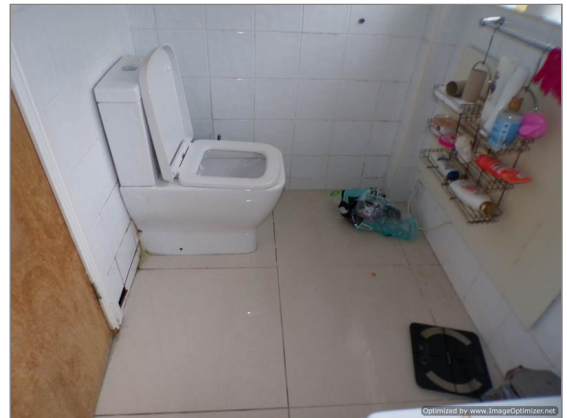
There is one bathroom with toilets in the property consisting of modern suites of sanitary fittings. Although they were not inspected in detail, they include a bath, toilet, and wash hand basin. These are in average condition. We cannot advise further on the suitability of pipe connections and waste.

Condition rating 3: Further leak investigation/general repairs and maintenance required.

The plumbing installations were not specifically tested. We recommend that an appropriately qualified person test them before purchase commitment to determine their condition under variable operational requirements.

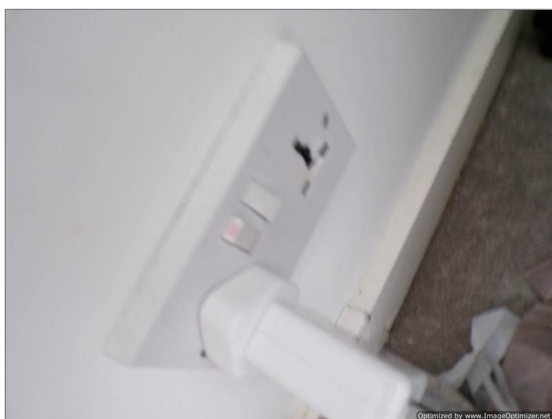
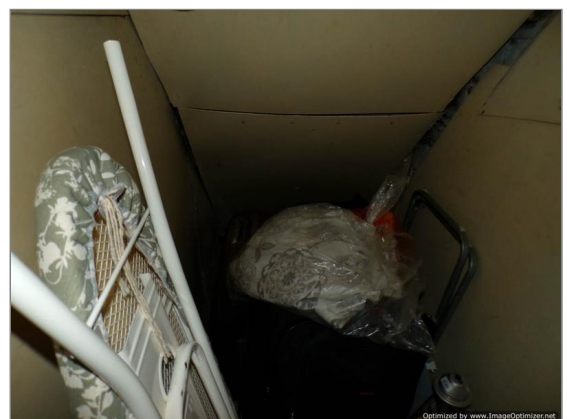
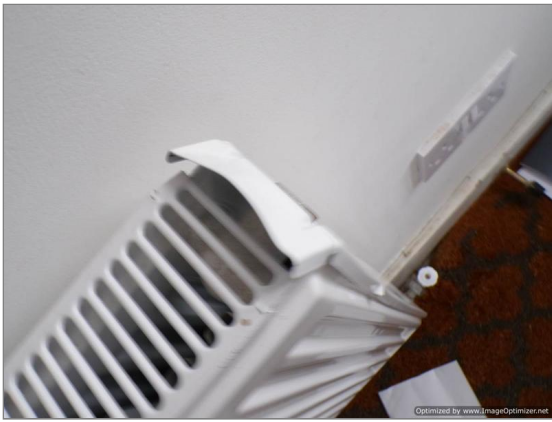
We noted a defective switch, defective sloped ceiling and radiator and we recommend repairs.

Condition rating 2: General repairs and maintenance are now required.

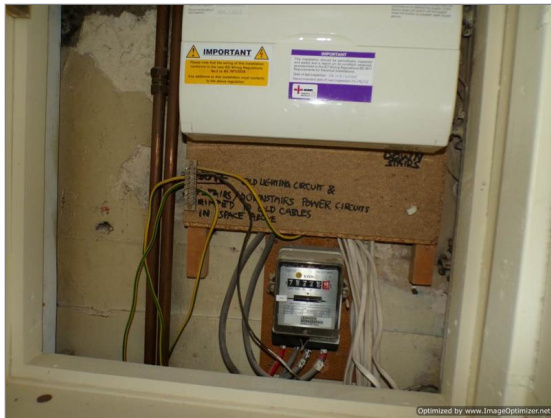
Photo - 178

Condition rating 3: Test electric installations.

An appropriately qualified specialist should be instructed before purchase commitment to confirm the full adequacy and compliance of the installation.

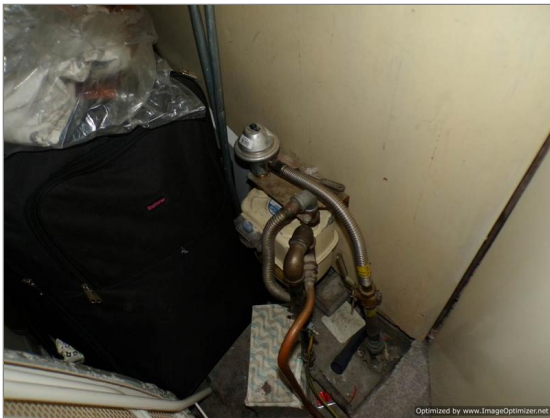
Photo - 179

Condition rating 3: Test gas installations and appliances.

It should be noted that all alterations or installation of pipework must be carried out by 'Gas Safe' registered contractors. You are advised to obtain a report and quotation from a Gas Safe registered engineer in respect of gas installations in the property.

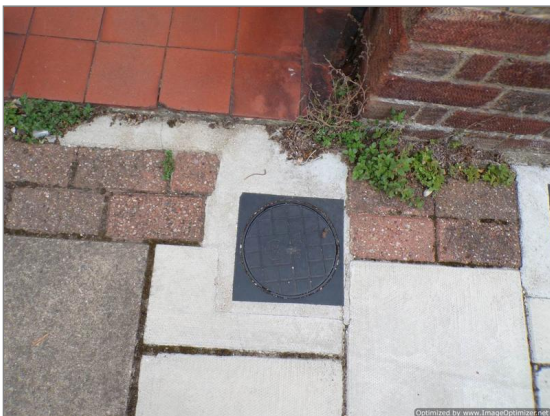
Photo - 180

The property is considered plumbed in plastic/copper, the suitability of pipe runs, spacing, clipping, and jointing are not readily determined. There was no obvious evidence of a defect noted at the time of our inspection. However, it is recommended that a qualified plumber should be instructed to report on the condition of all pipes, including the concealed ones.

Condition rating 3: Test plumbing connections

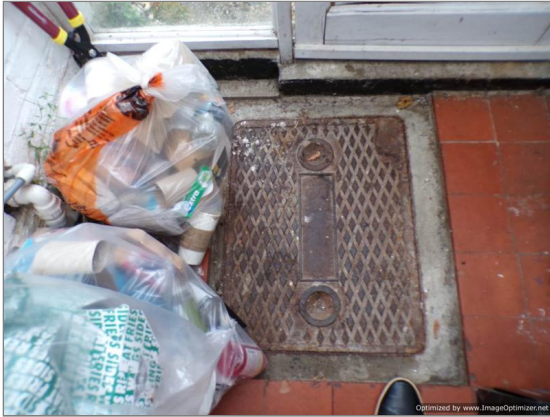
Photo - 182

Condition rating 3. Check the drainage system.

Drainage gullies should be cleaned and maintained on a regular basis to minimise the risk of blockage and as a precaution, all surface water gullies and drainage trenches within curtilage should be flooded prior to purchase commitment to determine their likely adequacy or otherwise under simulated storm conditions.

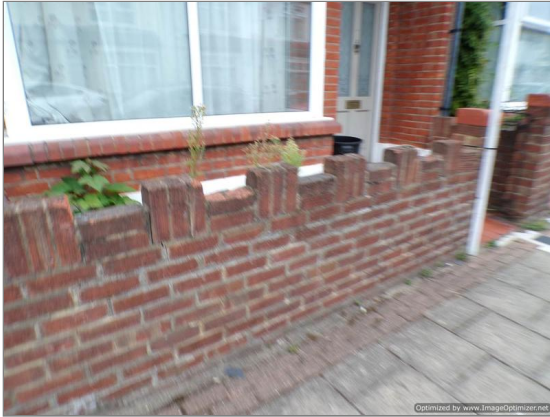
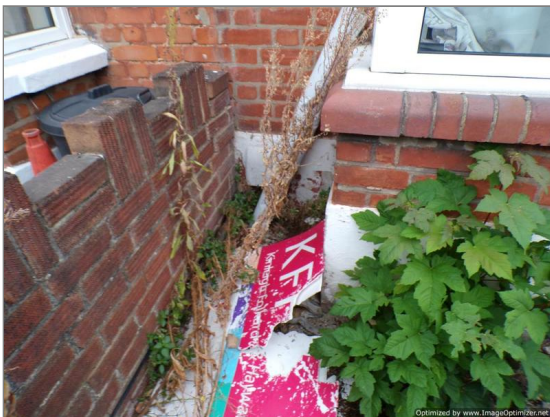
Condition rating 2: General repairs and maintenance required.
